Subject: Percolation Test, Inarajan Sewer Treatment Plant

Inarajan Percolation test MCB Rev 2006FEB06

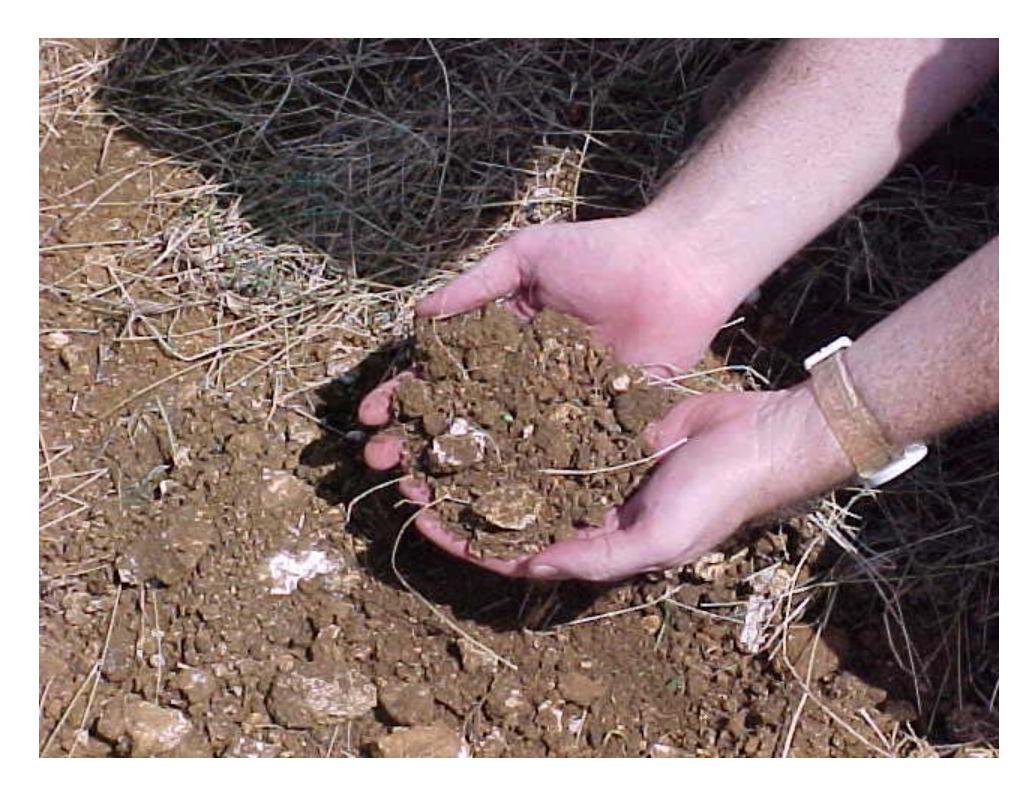
The soil outside and adjacent to the percolation basins was rocky with clayey sand (See Attachment 3 Photo 1). Due to the rocky nature of the soils surrounding the percolation basins, the project team was unable to hammer in the outer cylinder to the desired depth of 6 inches. As a result the project team dug earthen bunds which were approximately 21 inches in diameter and 6 inches deep.

Photo 1: Soils Encountered

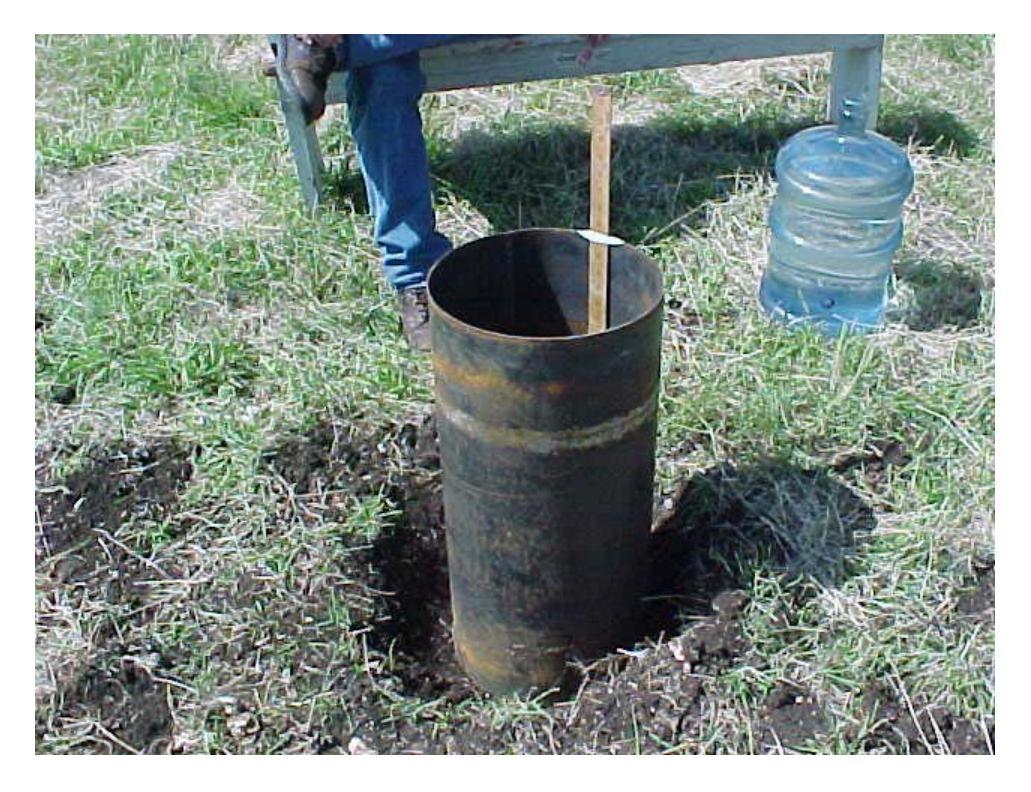
Photo 2: Percolation pit 1

- 1. Percolation pit 1: 2.5 in/hr
- 2. Percolation pit 2,: 2.25 in/hr
- 3. Percolation pit 3,: 3.75 in/hr
