Prepared for
Guam Waterworks Authority

Water Resources Master Plan Update

Volume 3: Wastewater System

Final | August 2018

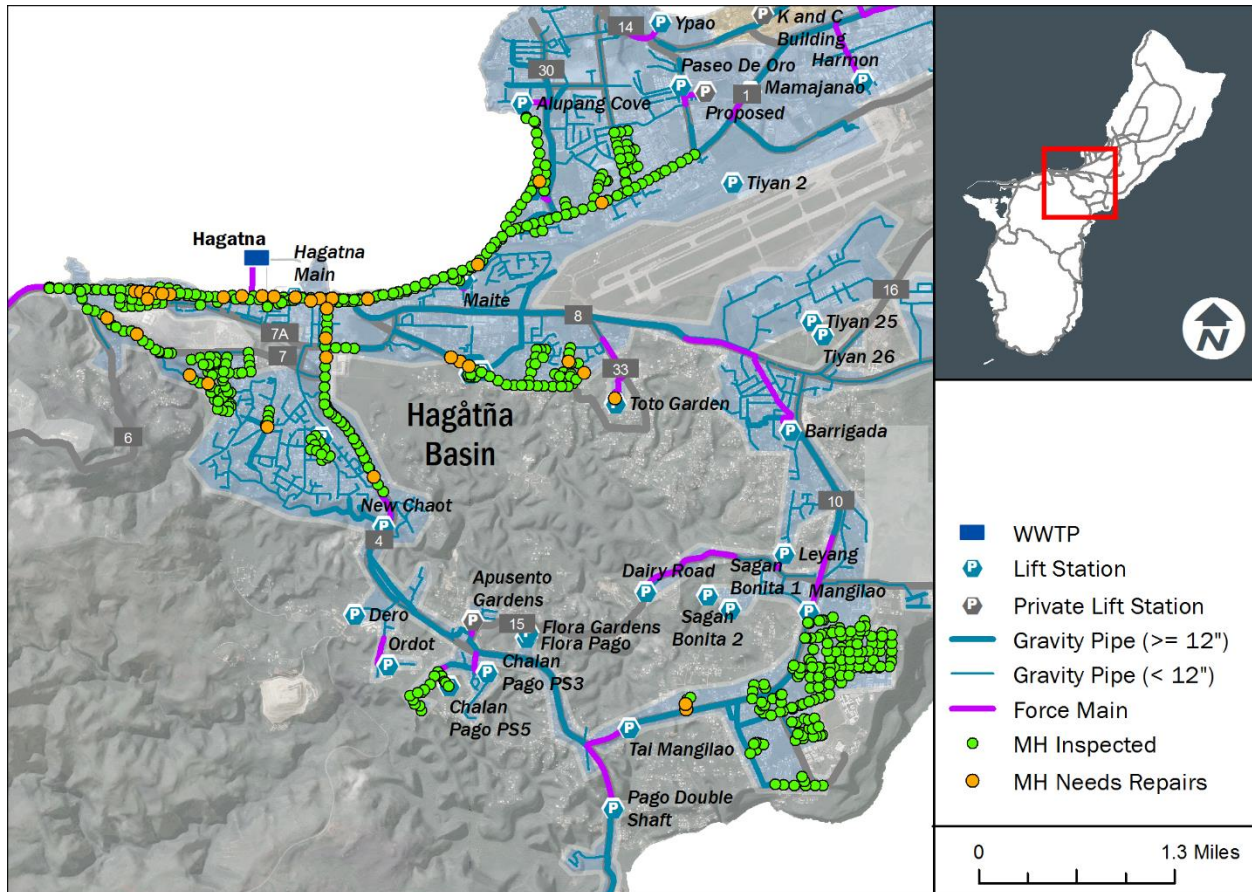
Figure 4-1. Priority Manhole Rehabilitation

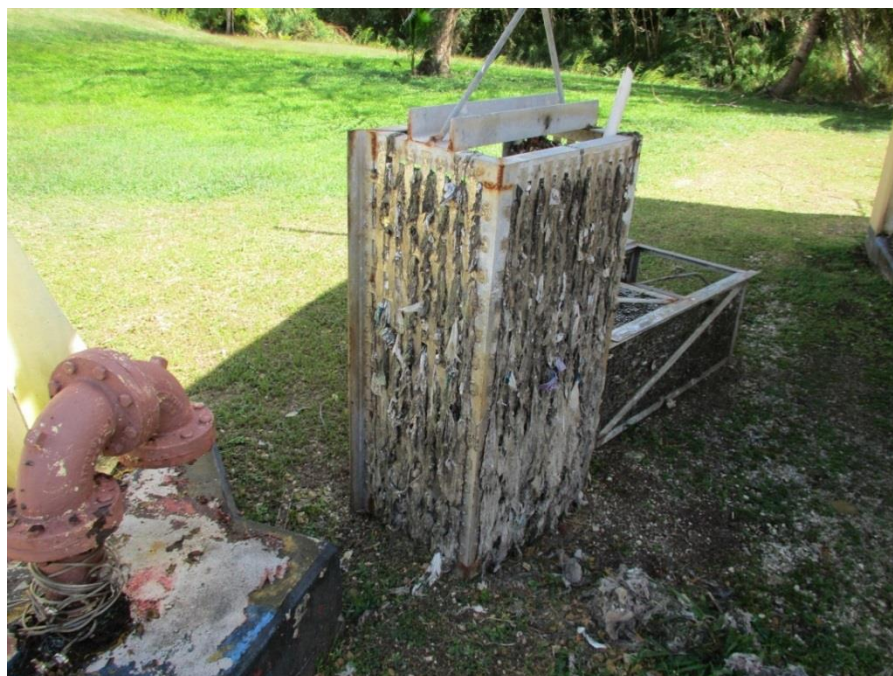
Figure 7-2. Umatac-Merizo WWTP Manual Basket Screen (January 2013)

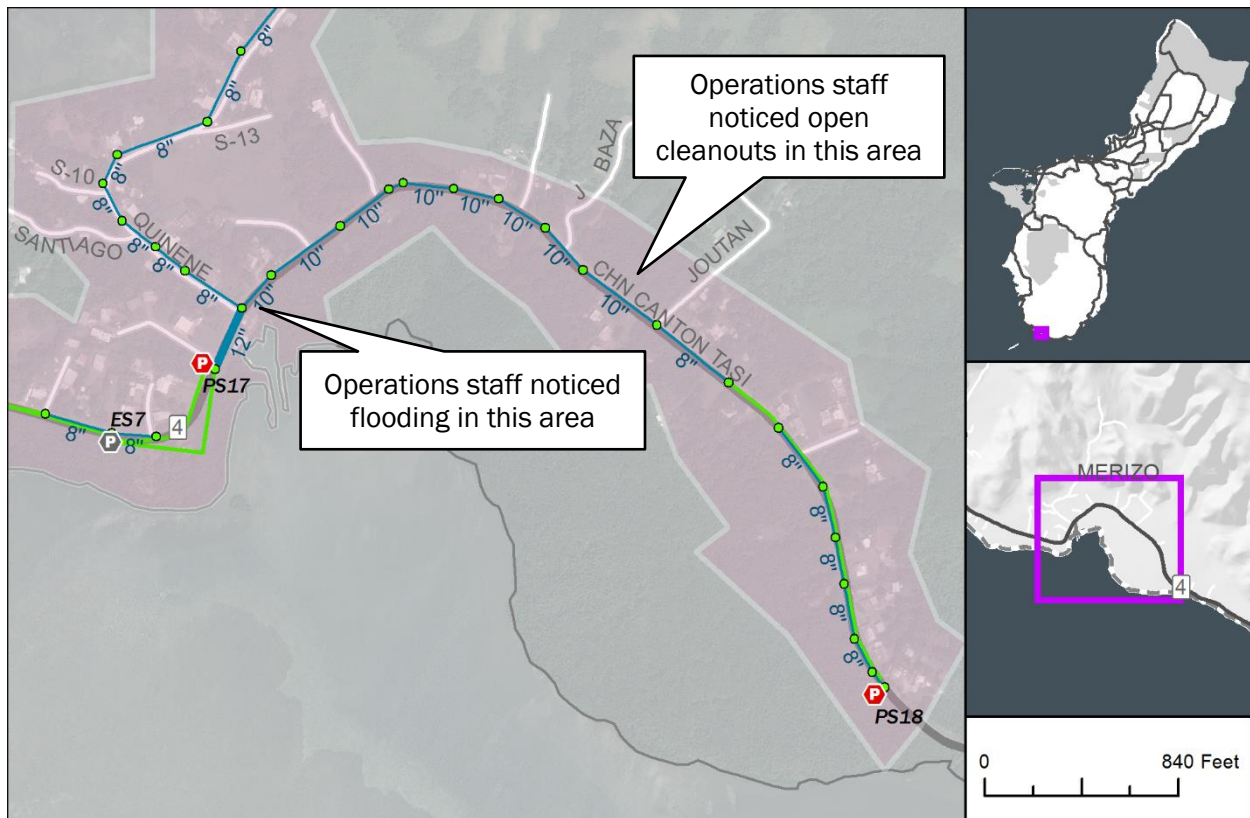
Figure 9-1. I/I Issues in Umatac-Merizo

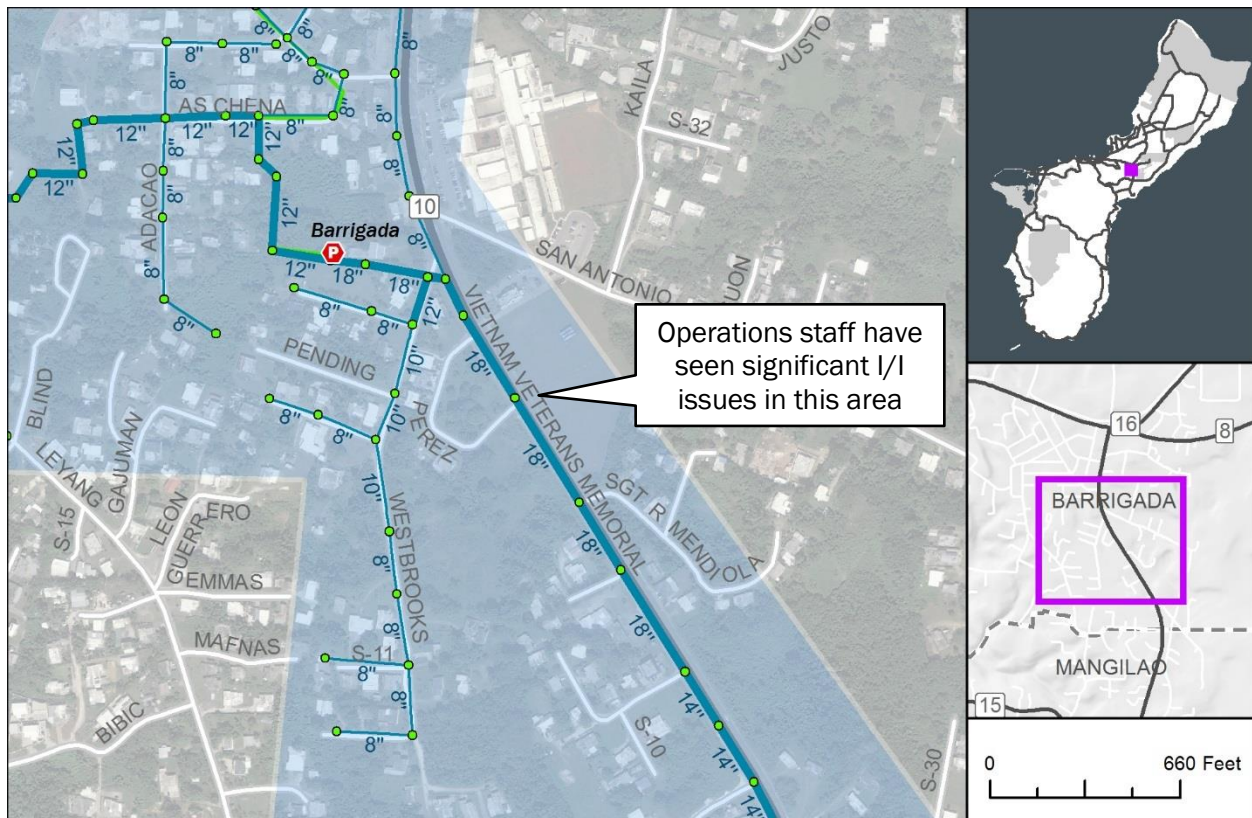
Figure 9-2. I/I Issues Near the Barrigada Pump Station
