CHAPTER 12 – ELECTRICAL ASSESSMENT

The purpose of this assessment report is to assist GWA with identifying, correcting and developing procedures to safely operate and maintain its electrical system, which is a vital component in providing water and wastewater services for the people of Guam.

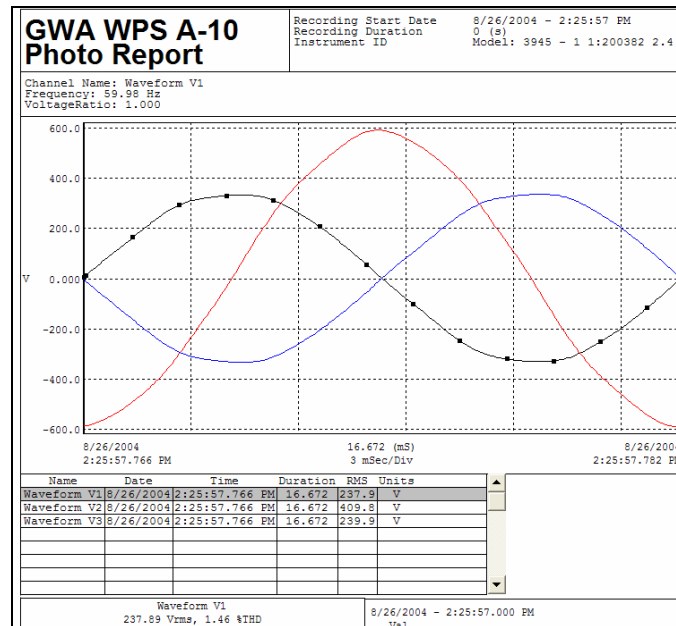
Figure 12-1 – Transformer Center Tap Grounded Voltage – Station A-10

A few stations were connected using a WYE configuration. These connections were predominantly ungrounded, although this system could be easily grounded. A few of the DELTA-configured stations were observed to be grounded at the center tap of one of the transformers. This configuration, however, places a high degree of electrical stress on one of the phase conductors to ground (416 volts versus 277 volts, or approximately 50% more). Figure 12-1, Transformer Center Tap Grounded Voltage – Station A-10 depicts the unbalance at Station A-10.

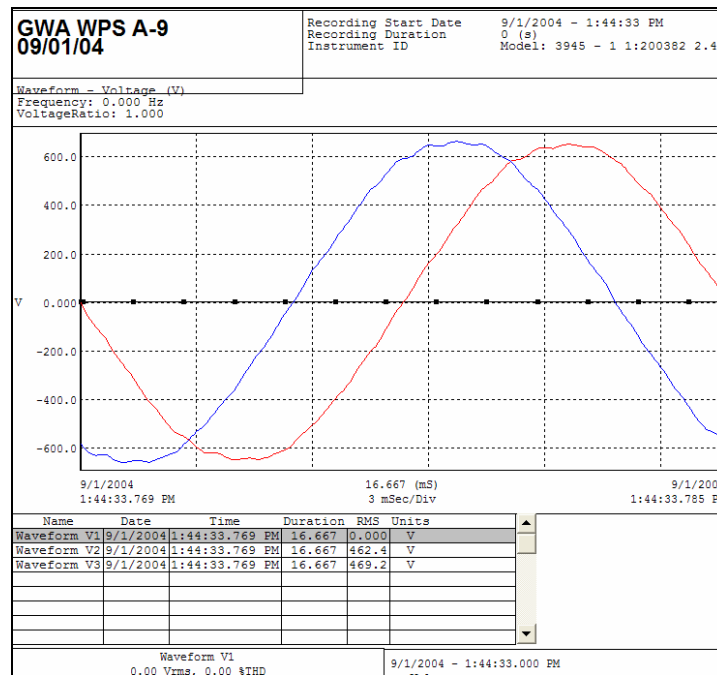
Figure 12-2 – Grounded Phase-to-Phase Voltage Recording – Station A-9

DELTA-configured transformer banks are typically used in industrial processes where experienced personnel are employed. An advantage of this configuration is that during a failure of one of the transformers the process could continue to operate in an open DELTA configuration. The conductors are coupled to ground using the system capacitance and can be measured using a high impedance meter. If the coupling is the same, the voltage to ground will be equal. If one of the phases starts to become grounded, the voltage will shift so that, at worst case, the voltage will be 480 volts to ground for the ungrounded phases and zero for the grounded phase. Figure 12-2, Grounded Phase-to-Phase Voltage Recording – Station A-9 presents a plot of this condition at Station A-9.

The condition depicted in Figure 12-2 occurs when one of the phase legs (V1) has gone to a ground condition. The other two phases (V2 and V3) are measured at 462 and 469 volts to ground, respectively. The insulation system is stressed to ground at phases V2 and V3. When either of these two phases goes to ground, a phase-to-phase short circuit will exist and a high fault current will flow. In many cases, this condition would continue undetected and is an electrical code violation.

At several stations, this condition was evident where holes were blown in the metallic raceway or gutter. At Station EX-11, the ground conductor carried the resistance-limited current causing the insulation to melt between the motor ground and the service ground.

Although the phase-to-phase voltage to the motor may be close to normal, corrective repair action must be implemented because failure is imminent.

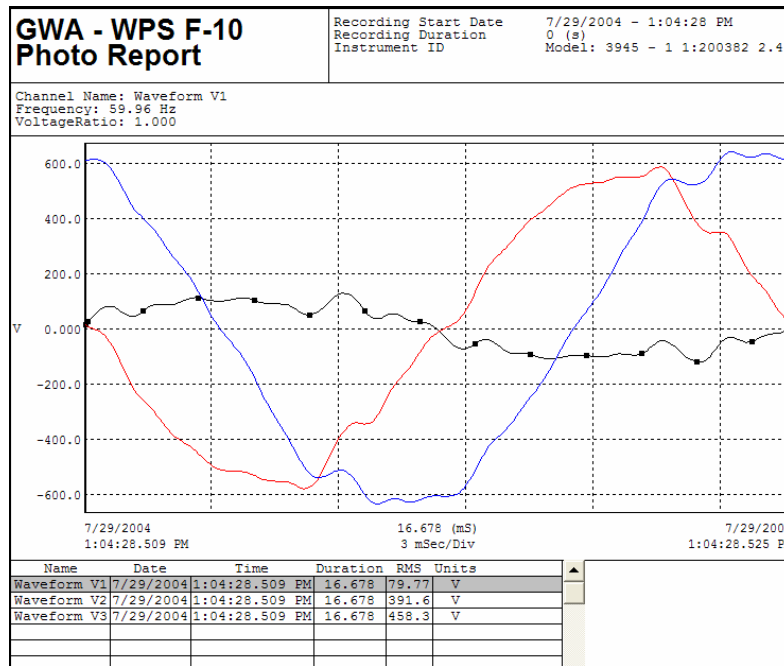
Figure 12-3 – Abnormal Phase-to-Ground Voltage Recording at Station F-10

At a few stations, voltages between zero and 90 volts were recorded between one phase conductor and ground. The other phases showed greater than 380 volts to ground. This is an indication that the neutral point has shifted and a ground condition will eventually occur, as depicted in Figure 12-3, Abnormal Phase-to-Ground Voltage Recording at Station F-10.

The condition depicted in Figure 12-3, occurs when one of the phase legs is connected to ground through the system impedance (capacitance reactance and resistance). This is an early indication that a part of the insulation has broken down in Phase V1. The voltages on Phases V2 and V3 are 391 volts and 458 volts, respectively.

The figure also exhibits a non-sinusoidal waveform, denoting the presence of harmonics caused by the systems inductive and capacitive reactance. With conditions favorable for a resonant condition, higher than nominal voltages can exist between one or two phases to ground. This will be exhibited only in the phase-to-ground voltage readings. These voltage readings were taken at the motor starter, with the unknown being the voltage at the motor termination. The motor would continue to operate with this condition undetected until a failure occurs.

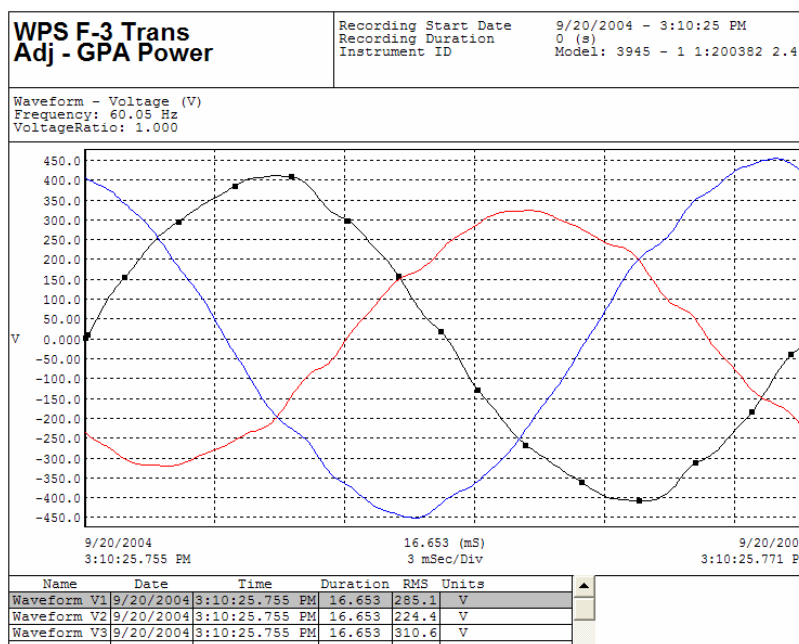
Figure 12-4 – Phase-to-Ground Voltage Recording – Station F-3

Figure 12-4, Phase-to-Ground Voltage Recording – Station F-3 presents typical voltage readings to ground, showing that the neutral point of the ungrounded DELTA has shifted from a normal 277 volts to ground to 224 volts to ground. This condition should be periodically monitored to determine whether a shift in voltage to ground continues, which indicates continued failure of the insulation level on the phase with the lower voltage, as shown in Figure 12-3. Note also the slight presence of voltage harmonics on the sinusoidal fundamental waveform.

A balanced, solidly grounded system would not exhibit a drastic variation of this condition. Rather, when the voltages to ground differ, it is an indication of a phase-to-phase voltage unbalance.

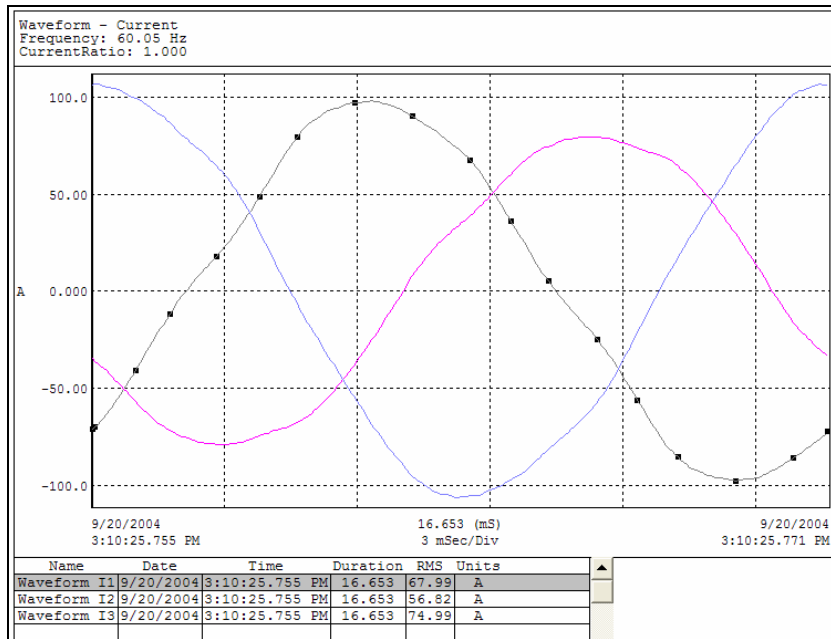
Figure 12-6 – Phase Current Recording – Station F-3

Figure 12-6, Phase Current Recording – Station F-3 shows the corresponding current during the same period as the voltage recording in Figure 12-4 (phase to ground) and Figure 12-5 (phase to phase).

$$\% \text{ Current Unbalance} = [(66.6 - 57) / 66.6] \times 100\% = 14.4\%$$

Despite the variables dealing with motor and installation practices, this figure depicts the relationship between voltage and current, wherein a voltage unbalance affects a consequent current unbalance.

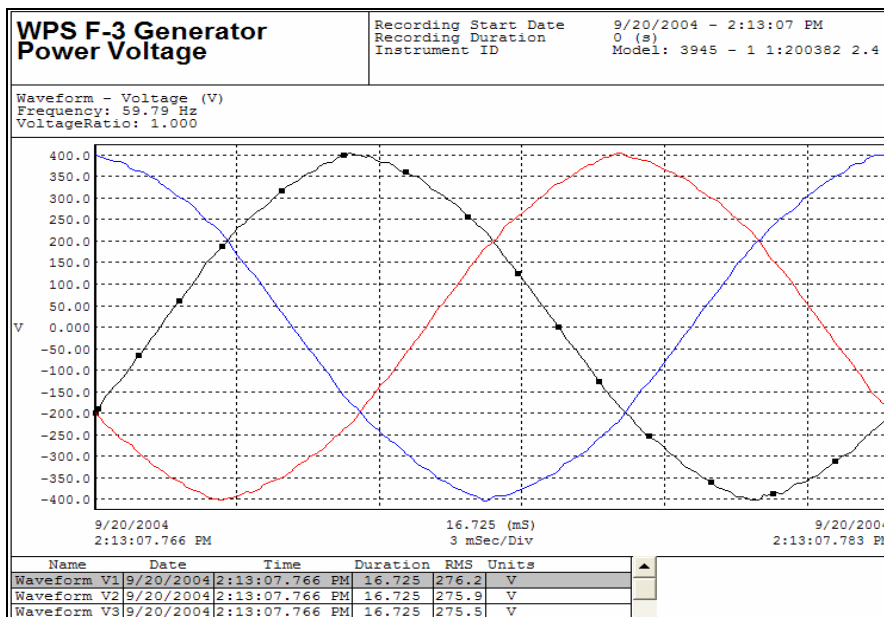
Figure 12-7 – Phase-to-Ground Voltage on Generator Power – Station F-3

As shown in Figure 12-7, Phase-to-Ground Voltage on Generator Power – Station F-3, Station F-3 was operated on the emergency generator with the voltage was recorded. This recording should also be compared with Figure 12-4 (on GPA power). Note also the balanced voltage to ground resulting from a grounded WYE connection within the generator.

The corresponding voltage unbalance is calculated to be 0.1 percent. This is an indication that the voltage unbalance (2.2 percent on GPA power and 0.1 percent on generator power) is largely attributable to the transformer voltage unbalance and service conductors. This is a good test example and method to determine the source of the voltage unbalance at any of the water and wastewater pump stations.

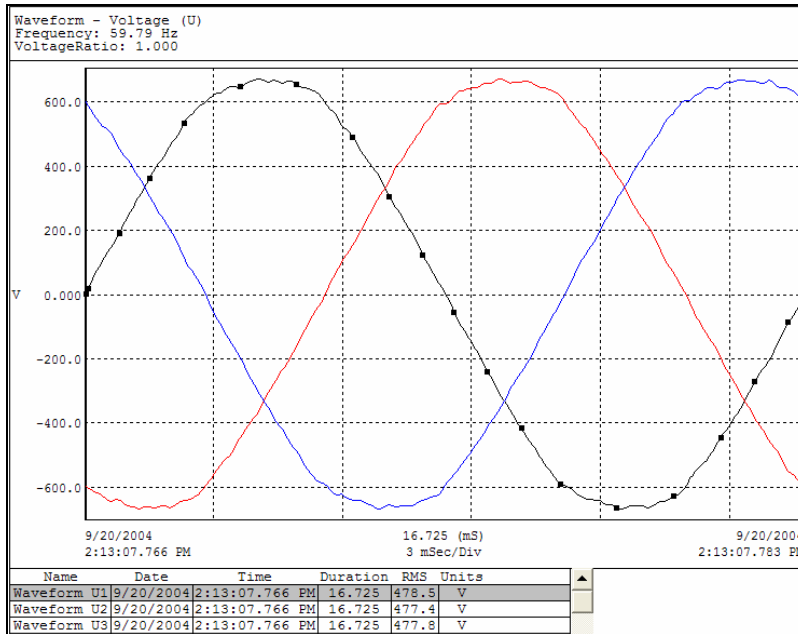
Figure 12-8 – Phase-to-Phase Voltage on Generator Power – Station F-3

Figure 12-8, Phase-to-Phase Voltage on Generator Power – Station F-3 shows the corresponding phase-to-phase voltage that the motor would be provided when operating on the emergency generator. The corresponding voltage unbalance is also 0.1 percent.

Although the phase current was not measured because the pump was not operated during this test, a balanced voltage will be the first step in determining the source of the unbalance condition.

Again, this is a test procedure to be implemented to determine the condition of the motor or equipment on GPA and generator power. See the Implementation Section 12.7.1 for a detail of this procedure.

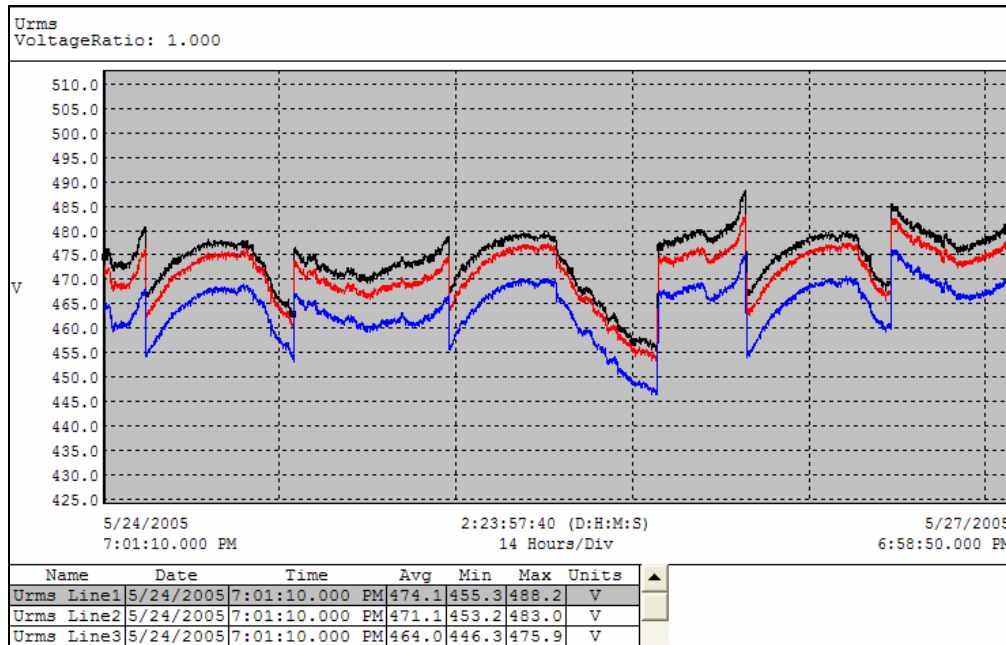
Figure 12-9 – Three-Day Trend Recording – Station M-20A – May 24-27, 2005

A three-day recording made at Station M-20A in May 2005 provided valuable information about the operation of the GPA electrical system. As shown in Figure 12-9, Three-Day Trend Recording – Station M-20A – May 24-27, 2005, the voltage recording showed a wide swing (490 volts to 445 volts). This variation was investigated by GPA and found to be caused by manual changes to the tap changer at the substation transformer. In August 2005, information was received that the tap changer, which normally operates automatically to adjust the voltage, was being repaired.

This is an example where multiple day recordings (minimum of three days) at the station were used to identify and aid in solving a challenge that has affected the M-20A well. The settings of the protective voltage and current sensing relays need to be studied, coordinated and adjusted.

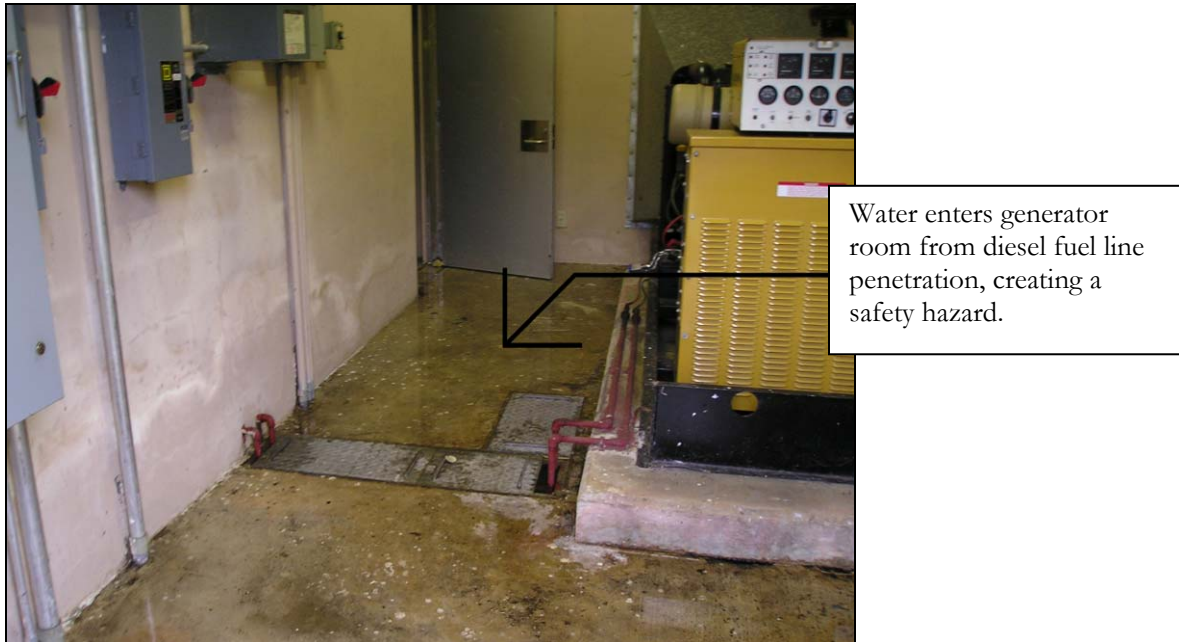
Figure 12-14 – Generator Room Fuel Line Penetration – Station A-3

The water in the diesel fuel trench and storage containment area also expedites the corrosion of the fuel lines to the generator, as shown in Figure 12-14, Generator Room Fuel Line Penetration – Station A-3. This could affect the proper operation of the generator in the future or allow water to enter the fuel system.

To reduce the effects of this condition, the containment area drain pipe was in an open position, allowing the water to drain. This practice, however, would also allow a diesel spill to drain in the same way, which is not desirable.

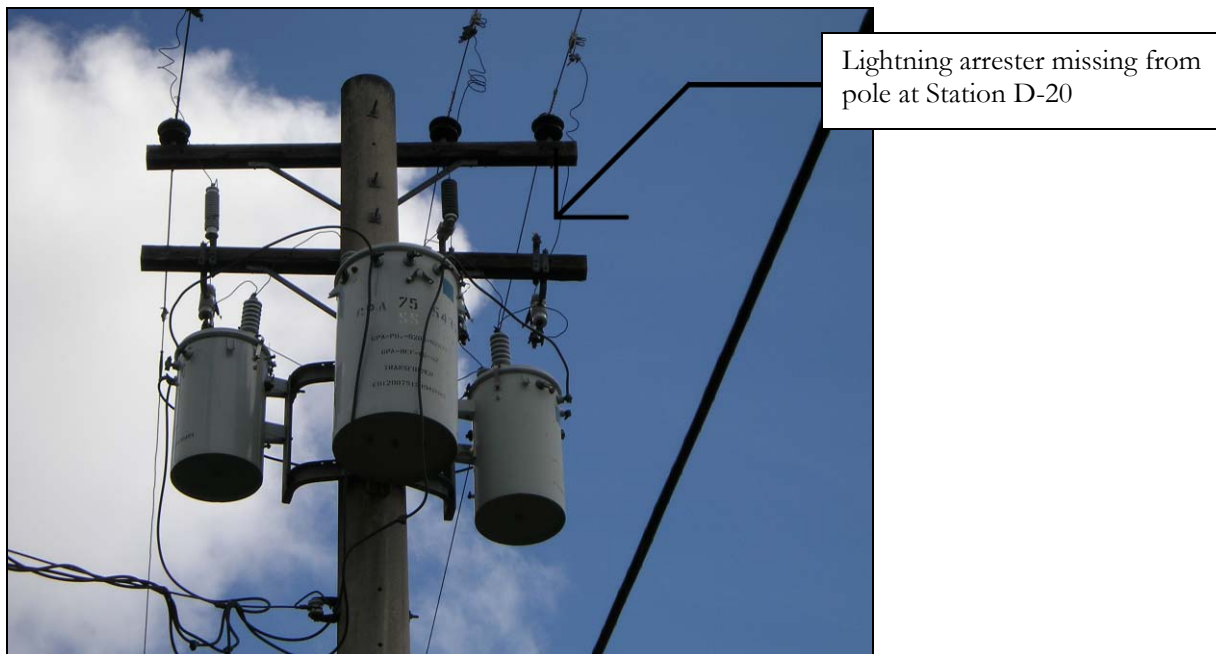
Figure 12-15 – Missing Lightning Arrester

This was evident at Station HG-2A after one of the transformers faulted to ground. When one of the fuses was replaced, the new fuse took about a second or two to blow, which is an indication of the limited fault current available on the 13.8-kV system at this station. The likely cause is the high impedance of the return path. This issue, however, is one that needs to be investigated by GPA.

The lightning arresters are the first line of defense in protecting the station. Most of the stations surveyed were not equipped with surge suppression devices to act as a second line of protection.

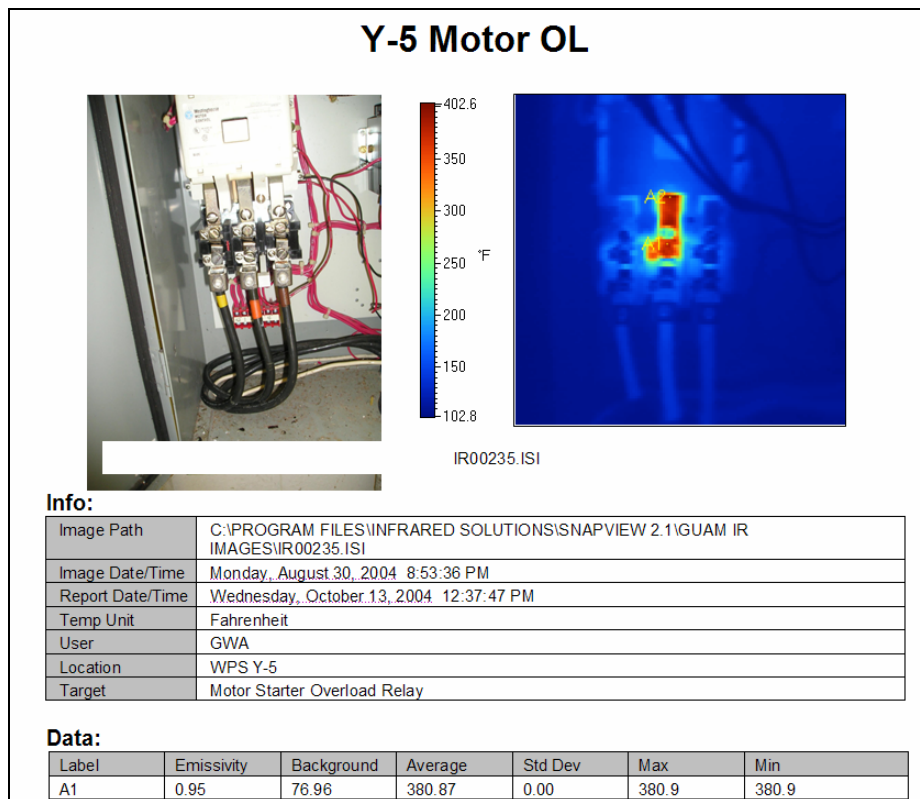
Figure 12-16 – Infrared Image of Motor Starter

Working in conjunction with a GPA infrared team is another method to conserve resources and provide cross training of personnel. Figure 12-16, Infrared Image of Motor Starter depicts an overheated overload condition at the Station Y-5 motor.

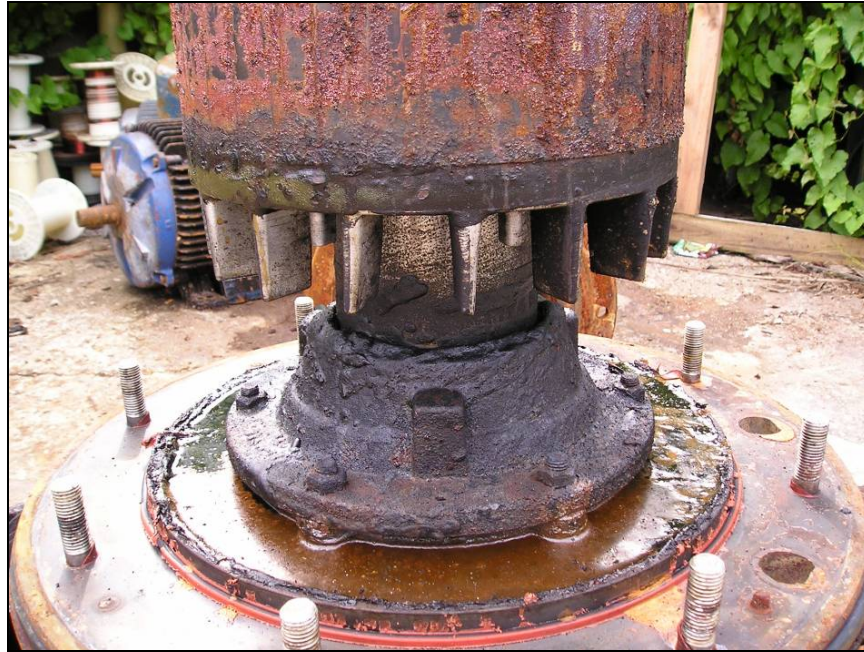
Figure 12-17 – Mechanical Failure in Submersible Motor

A high probability of seal failures could be attributable to the alignment method used to install the submersible pump. This is particularly true when mechanical means are used to force the piping to align with the pump or vice versa. The stress caused by this misalignment can cause small changes (in the tens of thousandths of an inch), sufficient to cause a seal to fail.
