Prepared for
Guam Waterworks Authority

Water Resources Master Plan Update

Volume 2: Water System

Final | August 2018

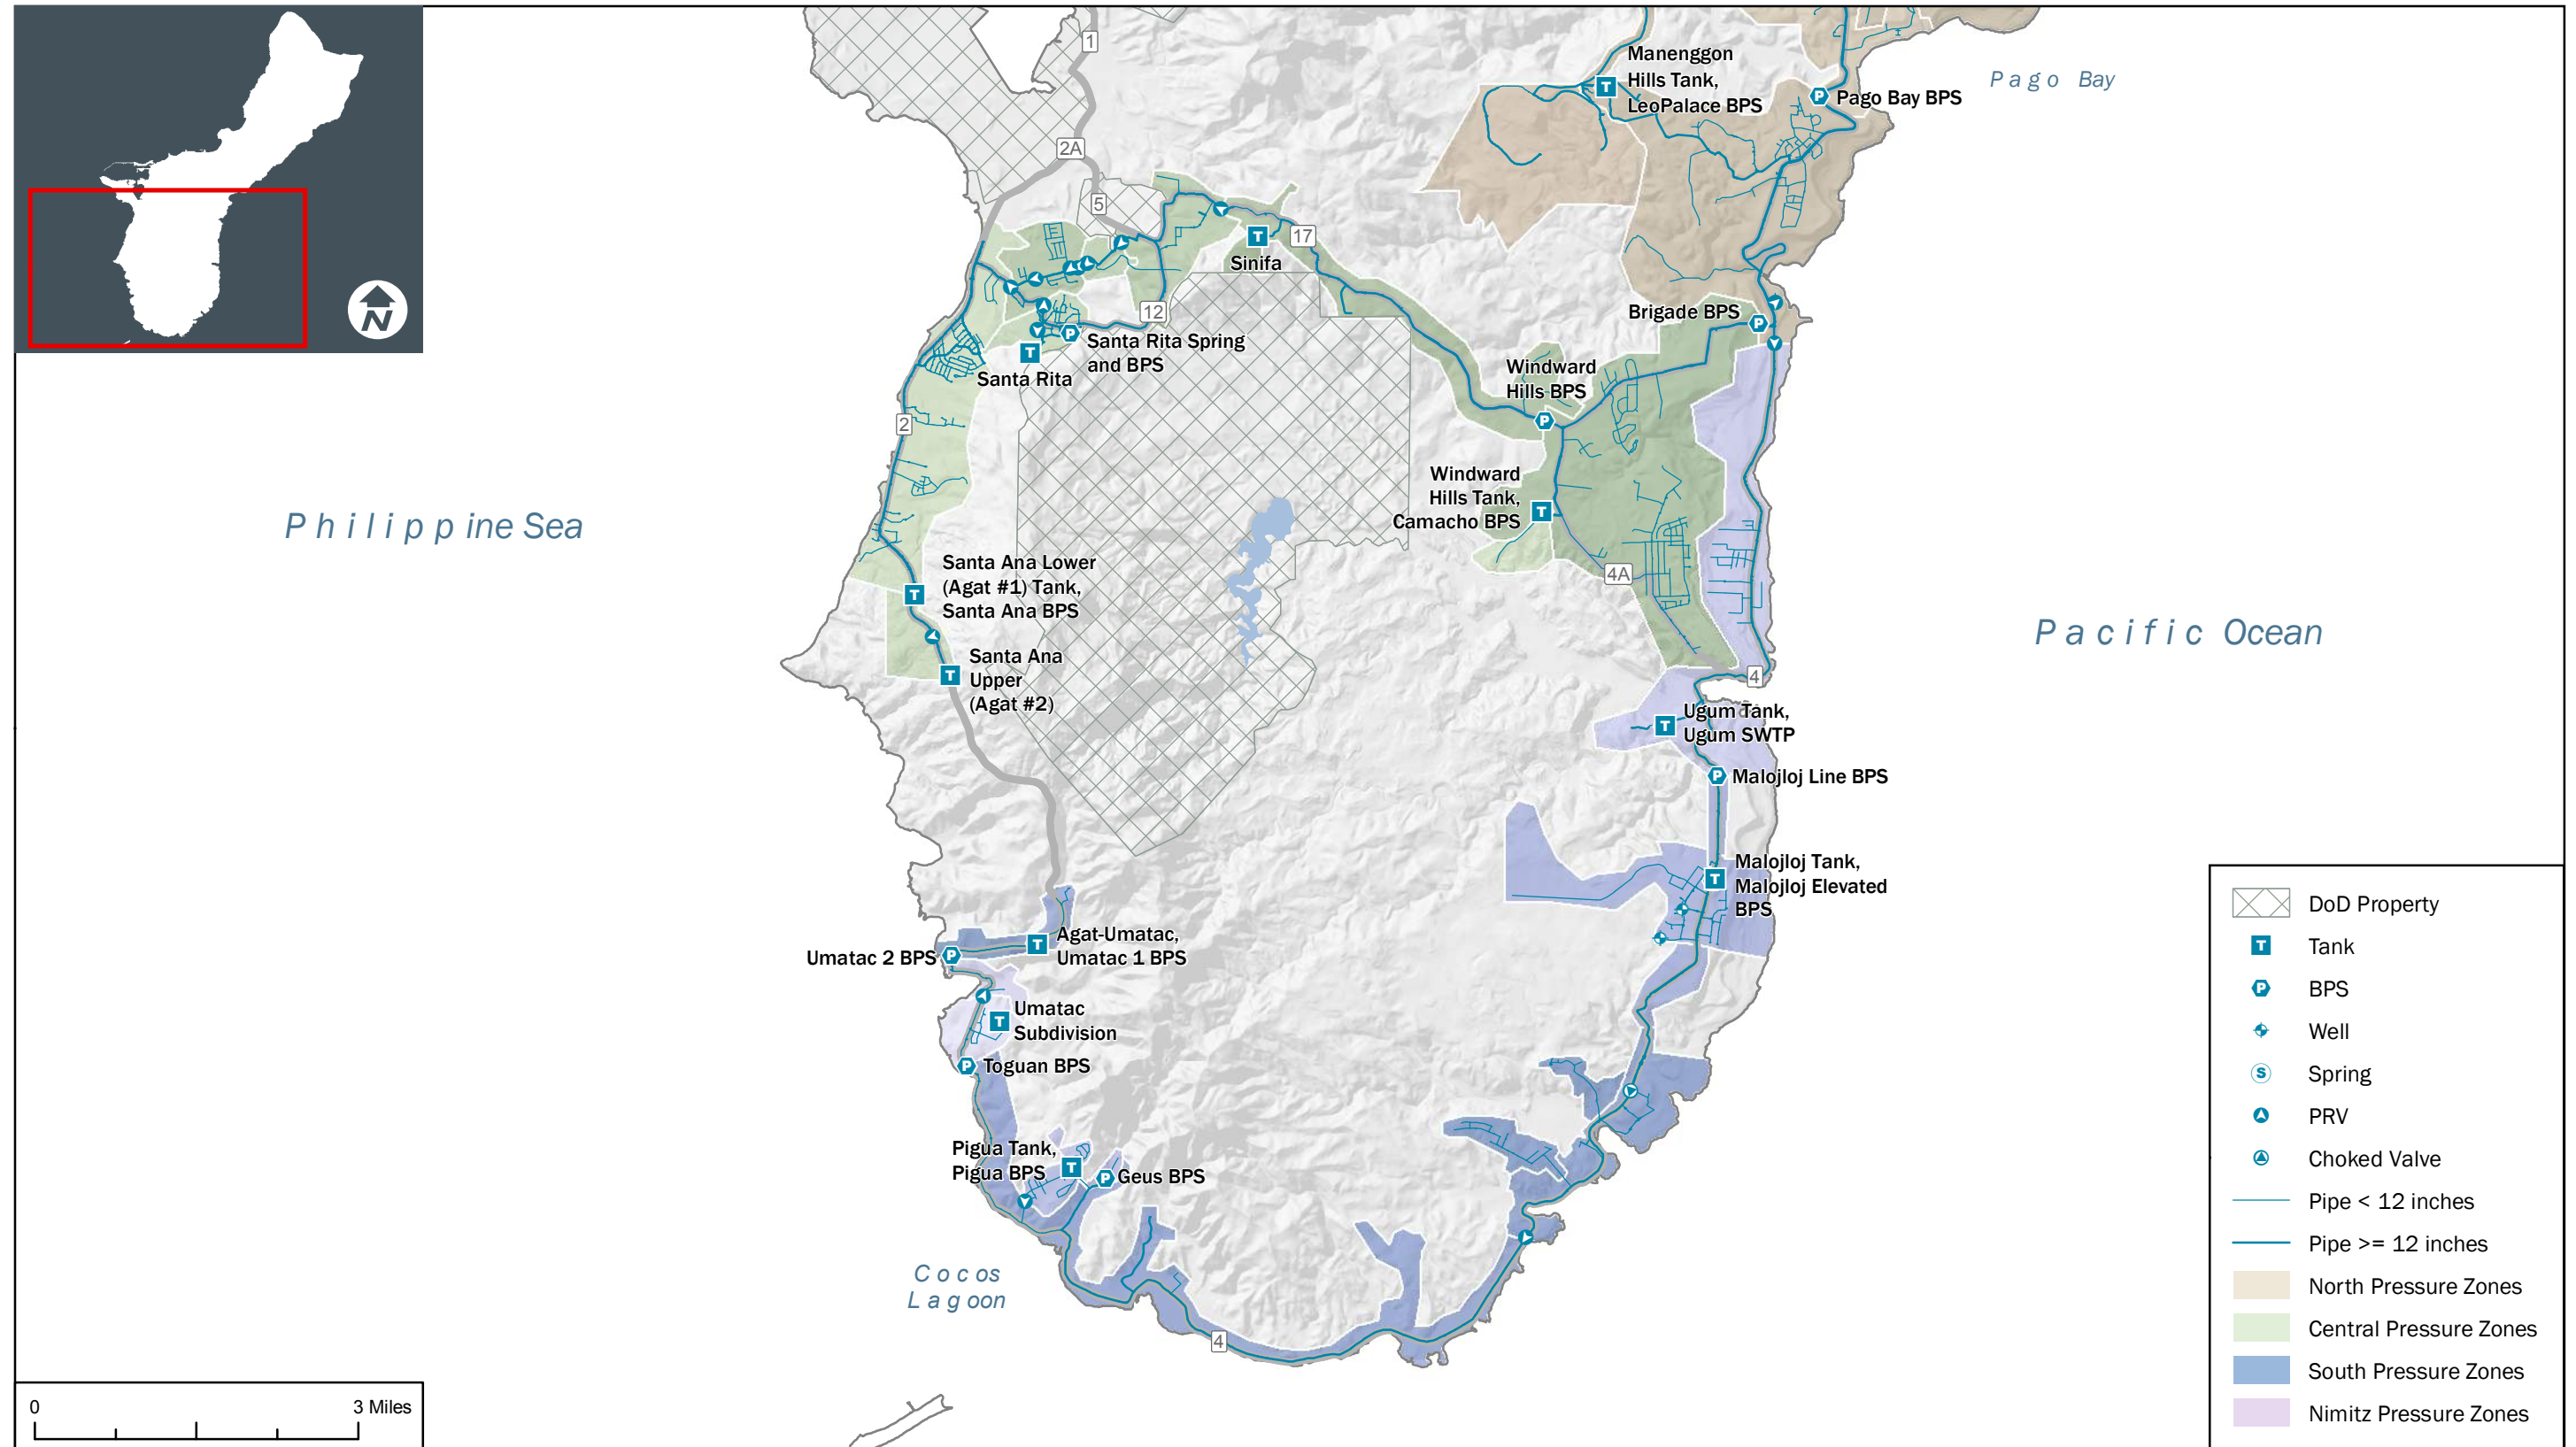
Figure 2-3. Water Distribution System (South and Central)

- **Figure 2-2 and Figure 2-3:** these figures show the location of GWA’s water system facilities, including the facilities listed above.
- **Figure 2-4 and Figure 2-5:** these figures are hydraulic schematics of the water system that illustrate the relationship between supply, pumping, and storage facilities. Storage tanks and the areas they serve are illustrated relative to their actual elevations. Other facilities including BPSs, wells, valves, and piping are not shown at their actual elevations.

The water distribution system includes approximately 38 PRV vaults (not including small PRVs to serve one or a few customers). Each vault includes one, two, or three PRVs. Some PRVs are operational, some are abandoned, some are bypassed, and the condition of others is unknown. Each PRV was surveyed in 2014; however, the operational status of some PRVs could not be determined at that time (for example, ports were not available at some PRVs to check pressures across the PRV). Figure 2-2 and Figure 2-3 show the locations of the PRVs.

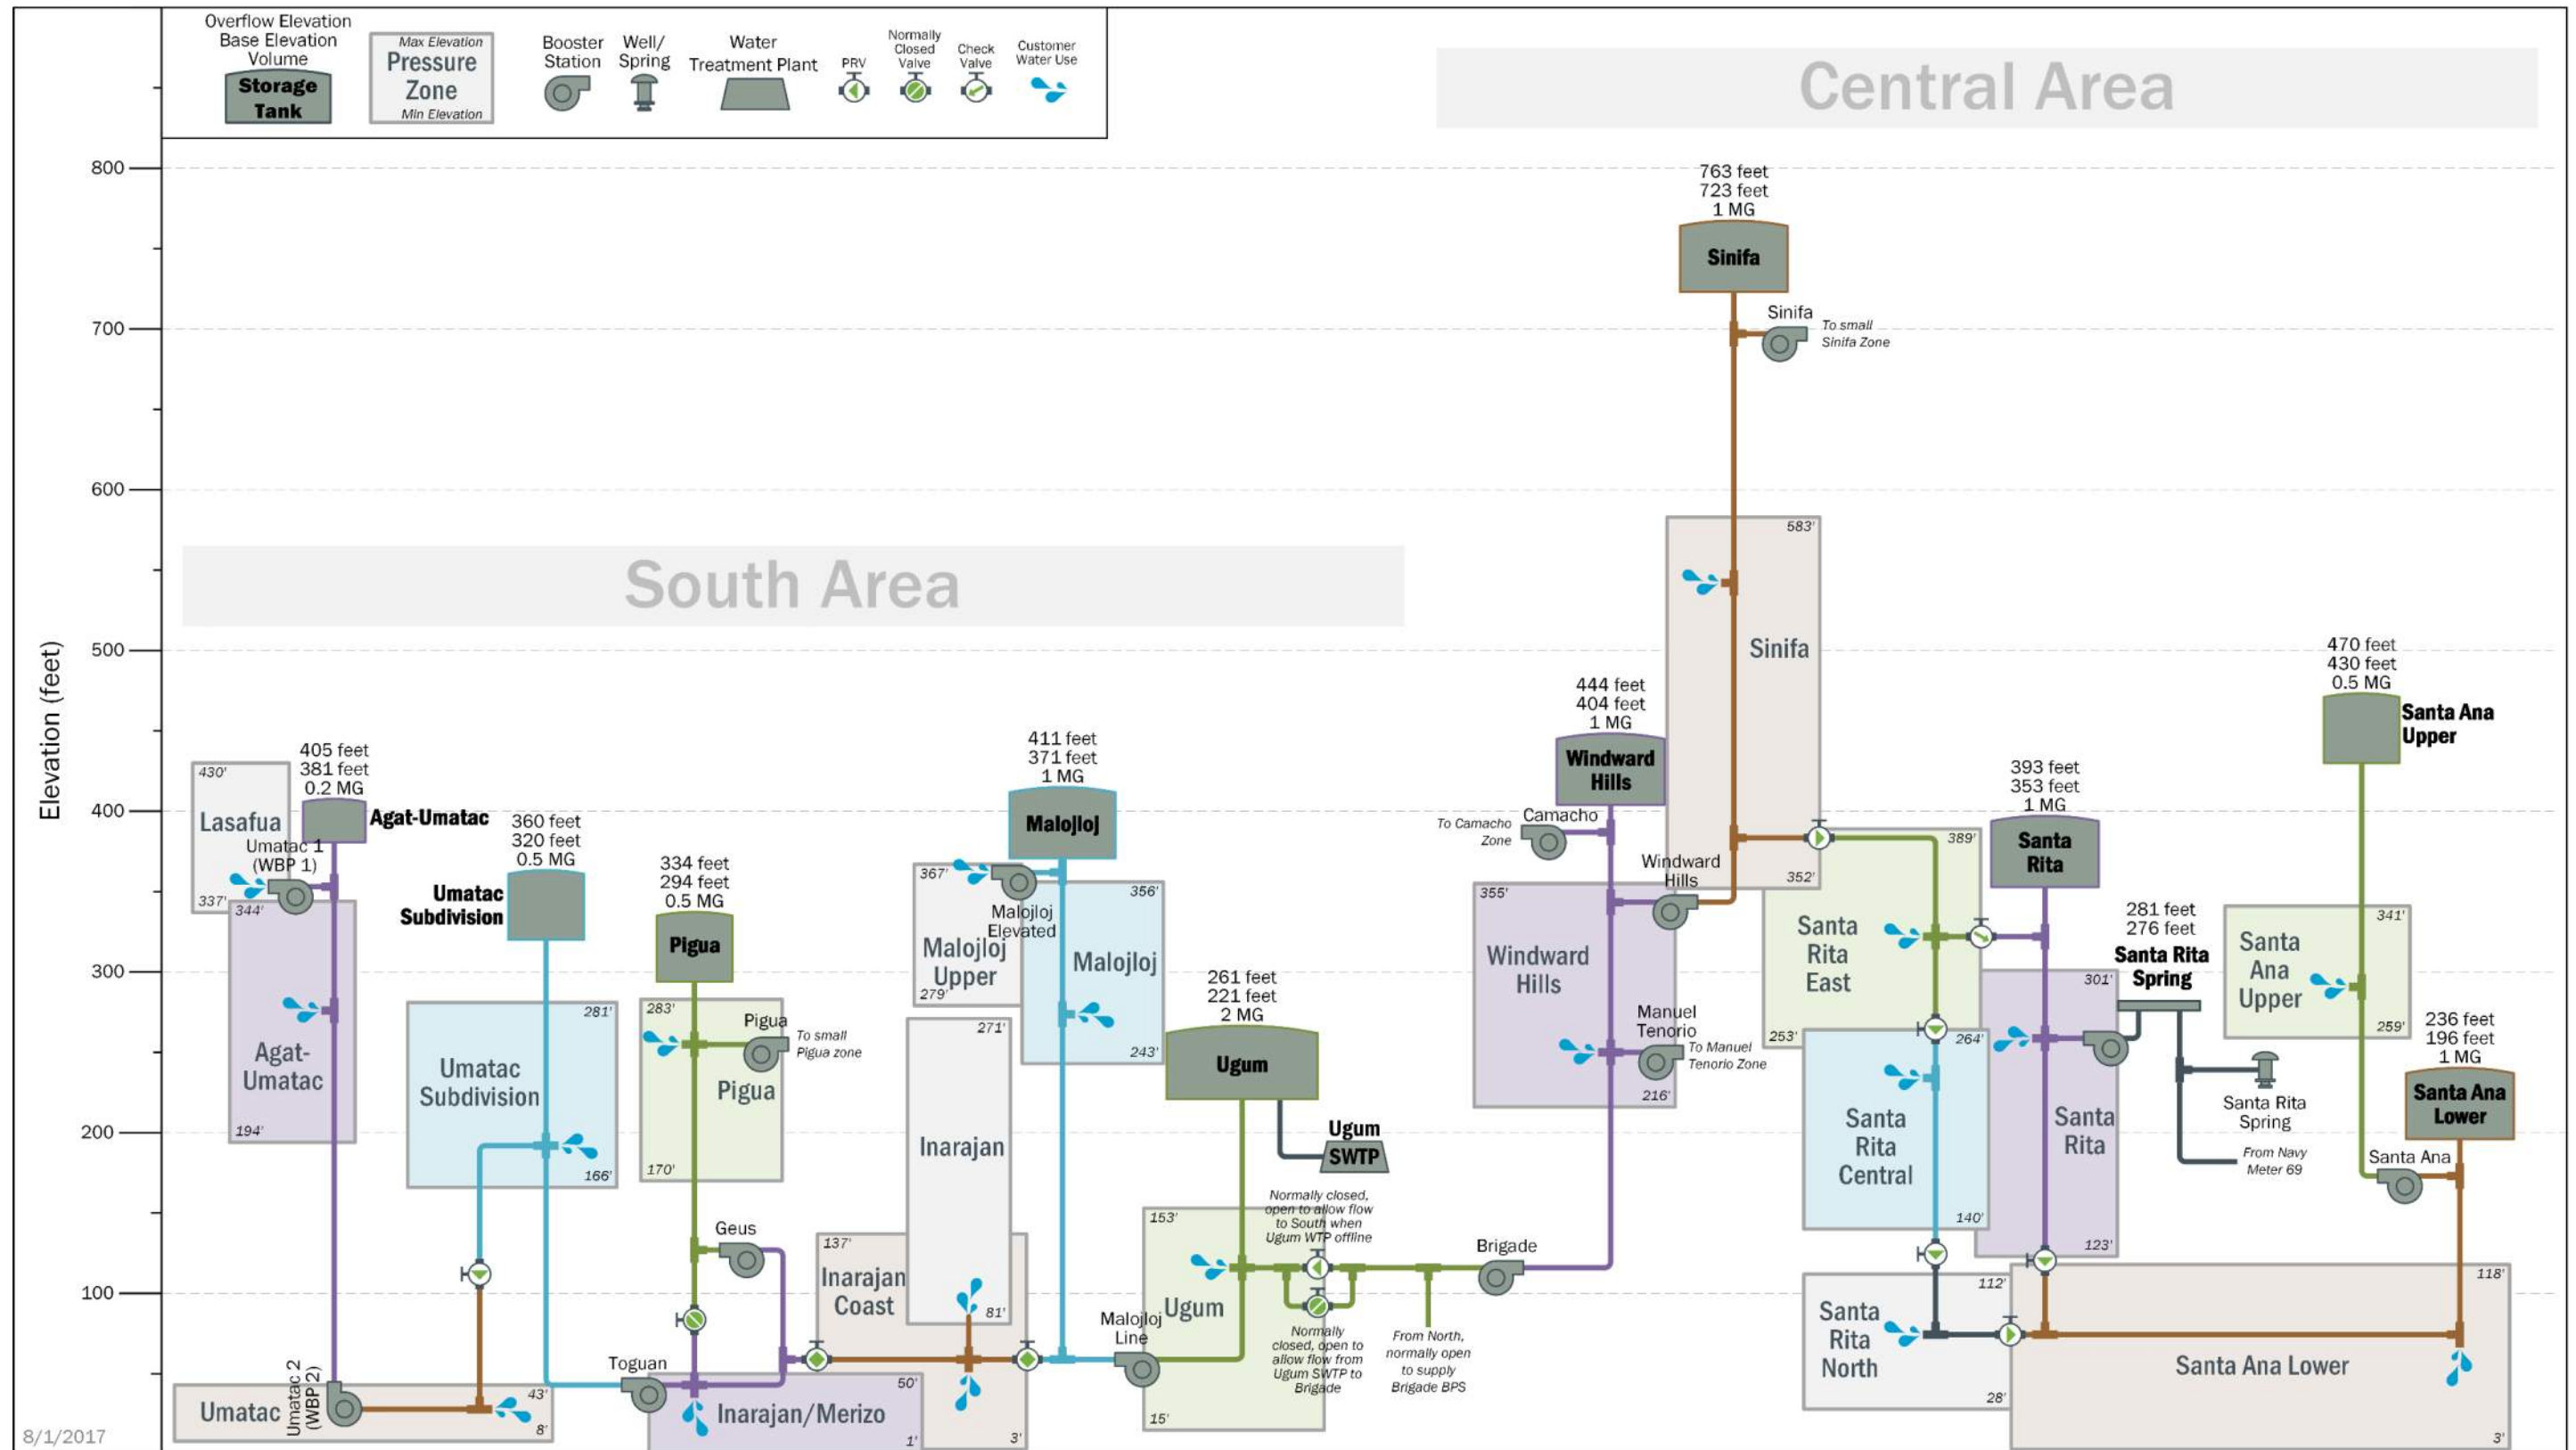
Figure 2-5. Water Distribution System Hydraulic Schematic (South and Central)

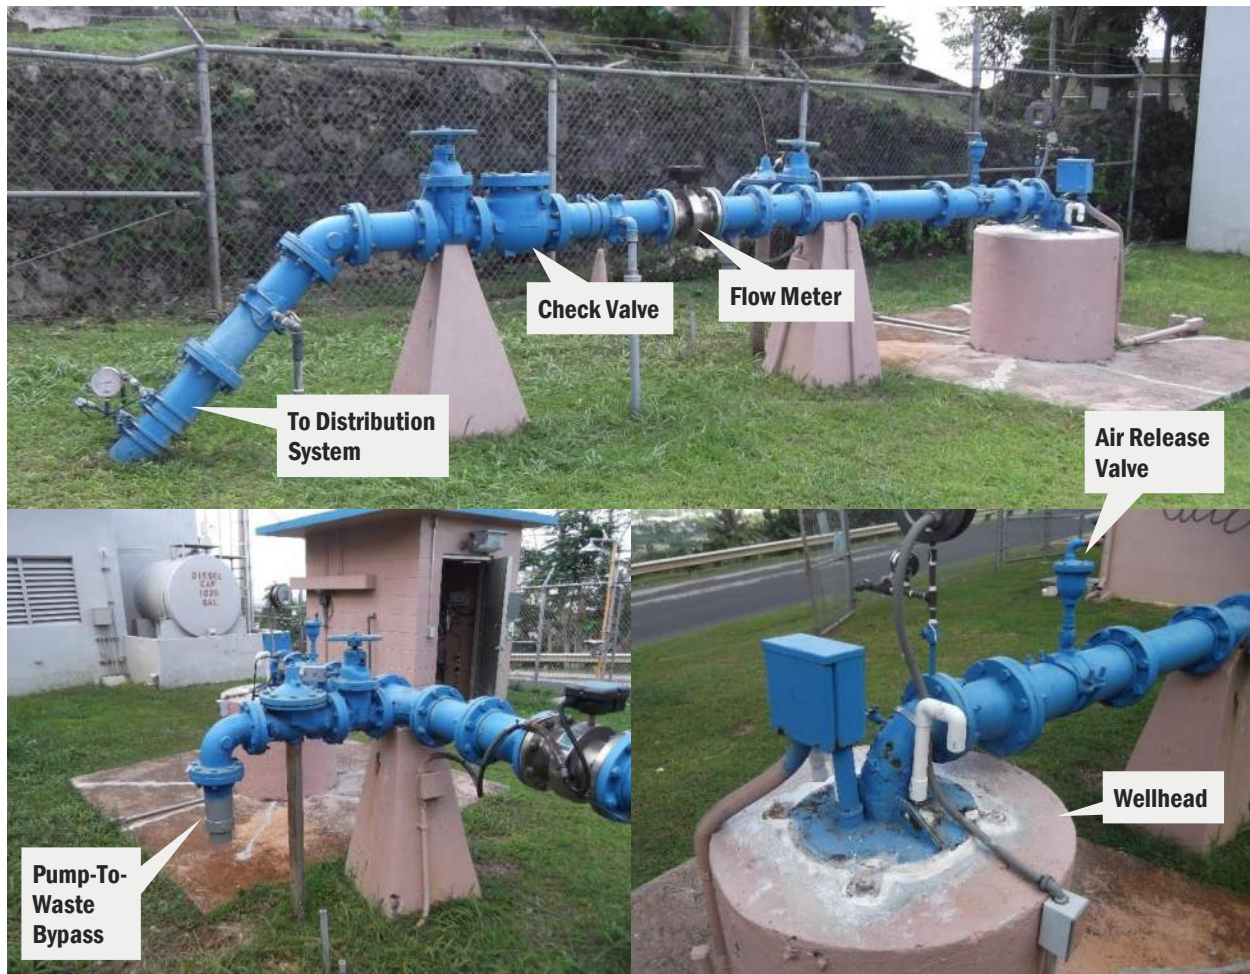
Figure 3-1. Typical Well Site

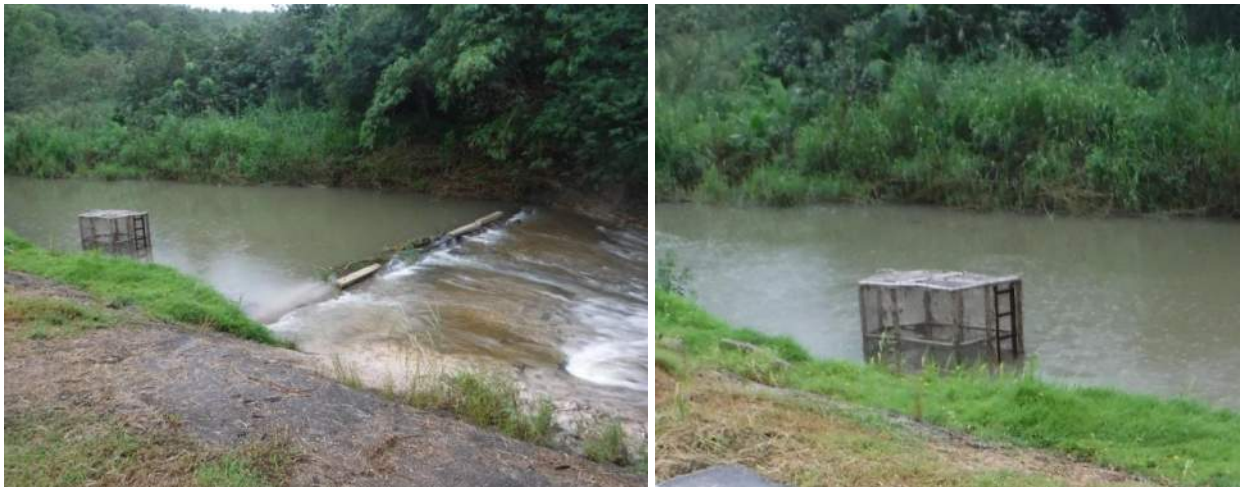
Figure 5-2. Dam with Stop Logs in Place (left) and Intake Screen (right)

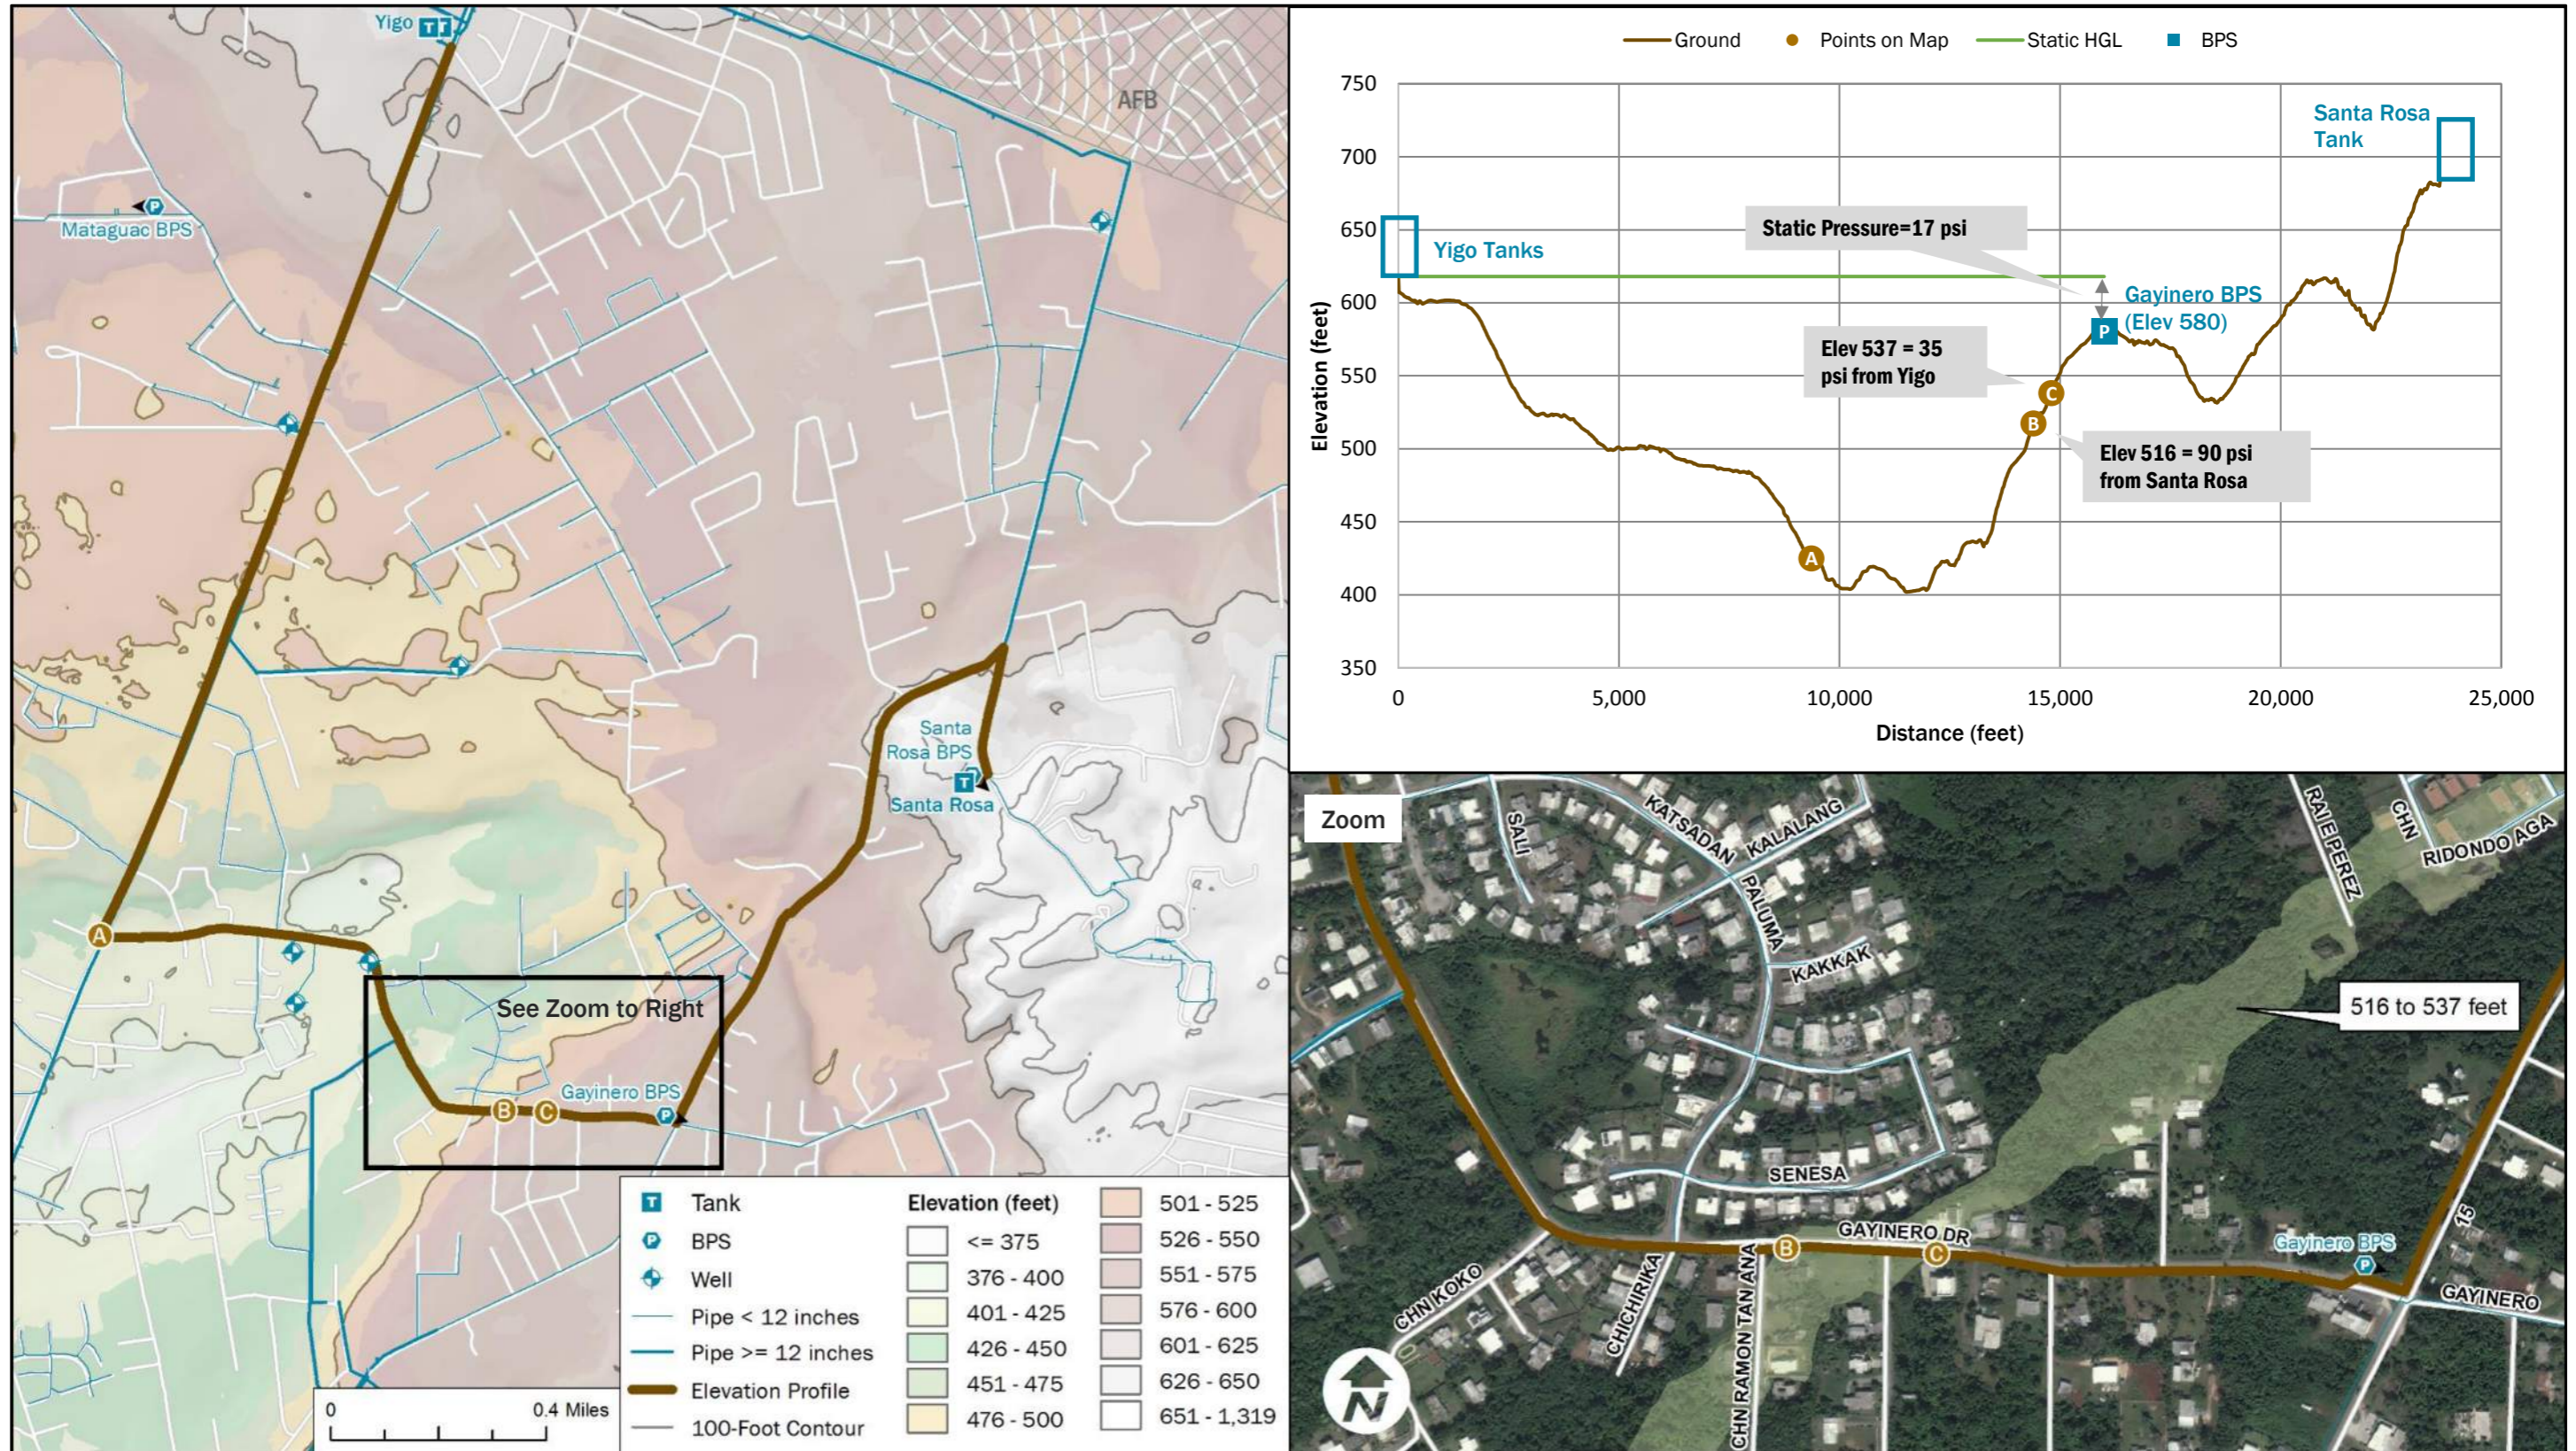
Figure 7-1. Profile of Piping from Yigo Tanks to Gayinero to Santa Rosa Tank

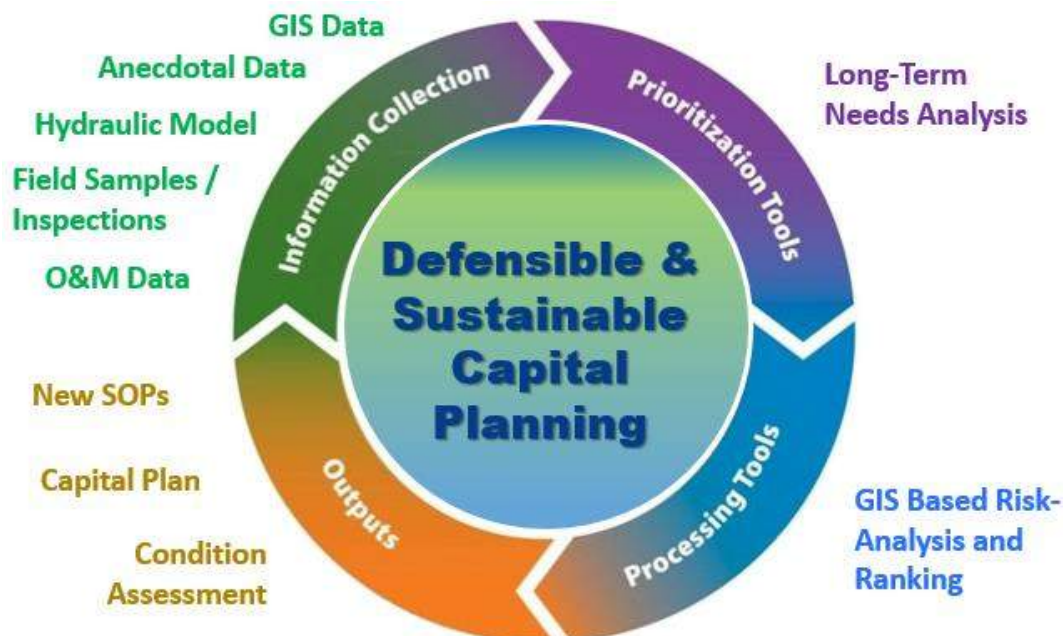
Figure 8-5. Diagram of the Approach to Ranking Water Piping

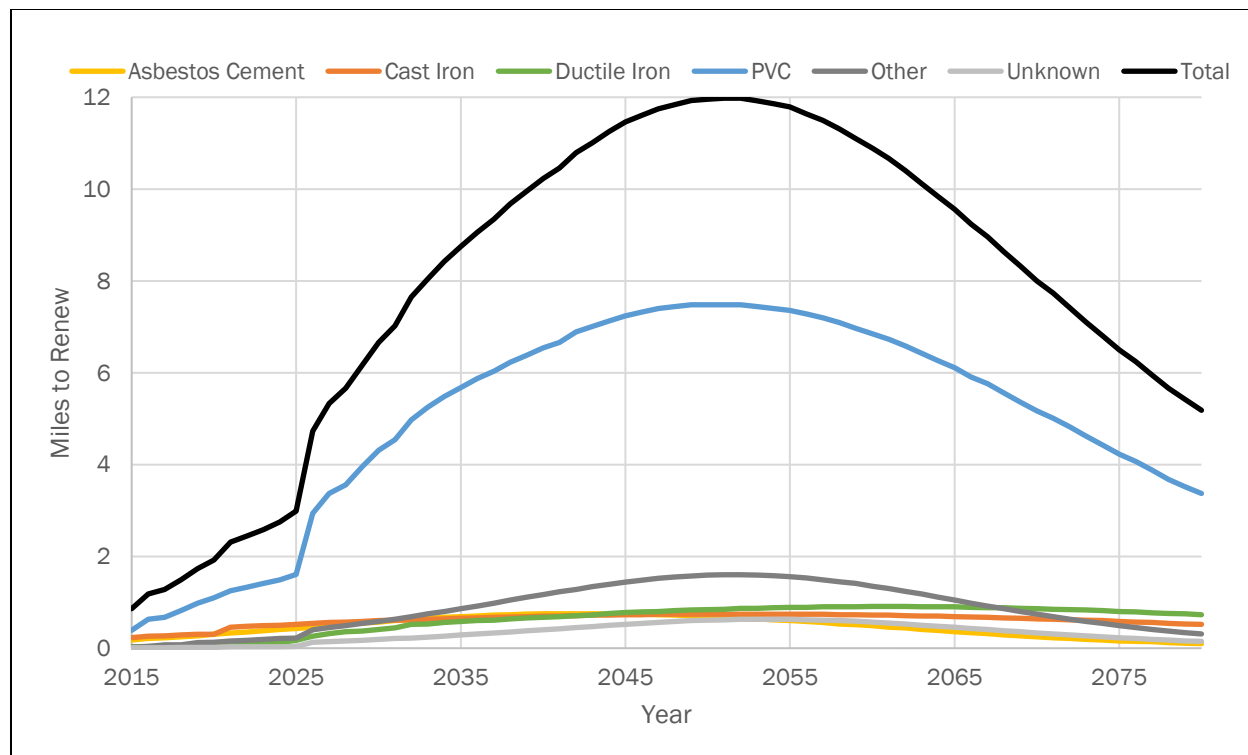
Figure 8-6. Pipeline Renewal Needs by Year

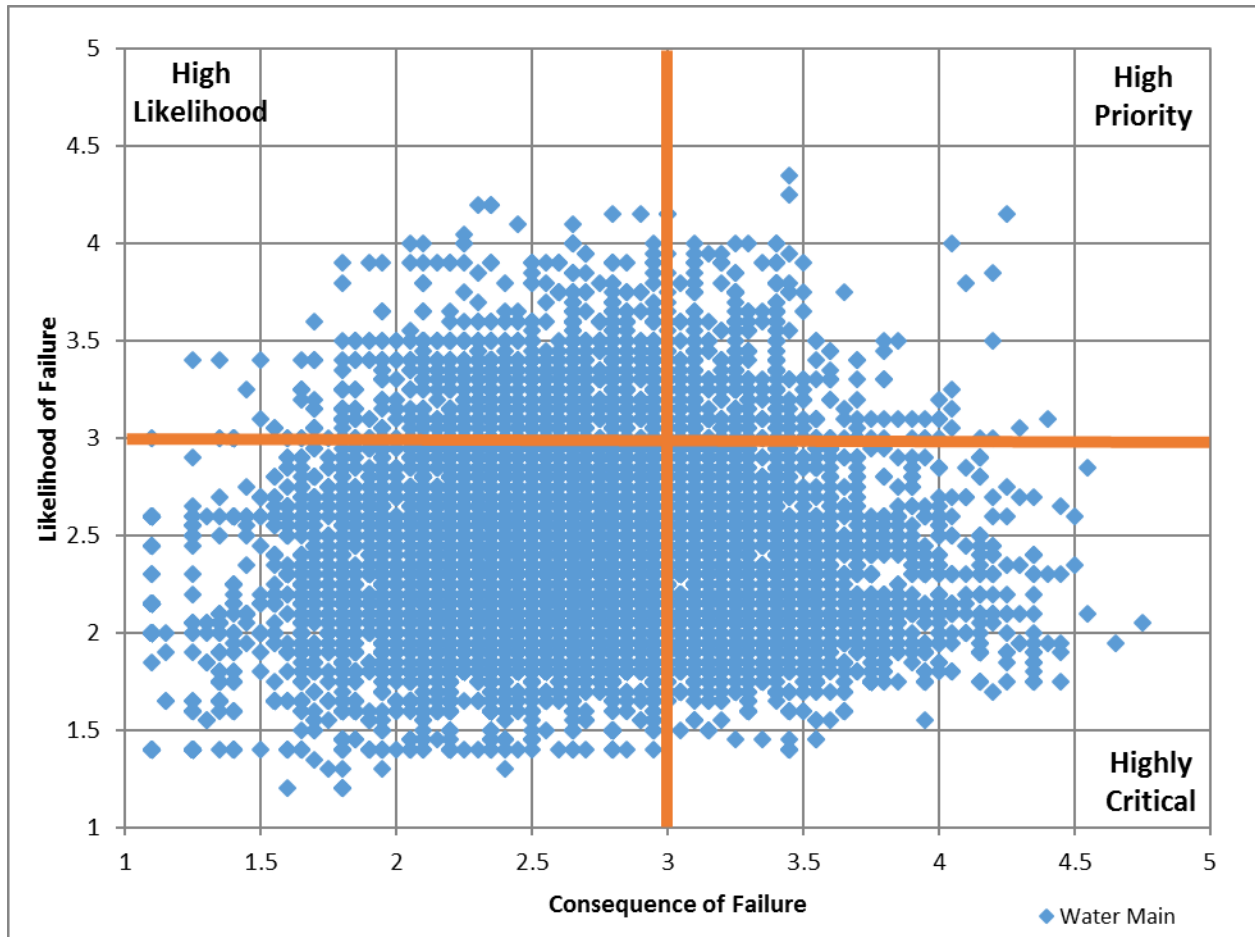
Figure 8-7. Likelihood and Consequence of Failure Results by Risk Category

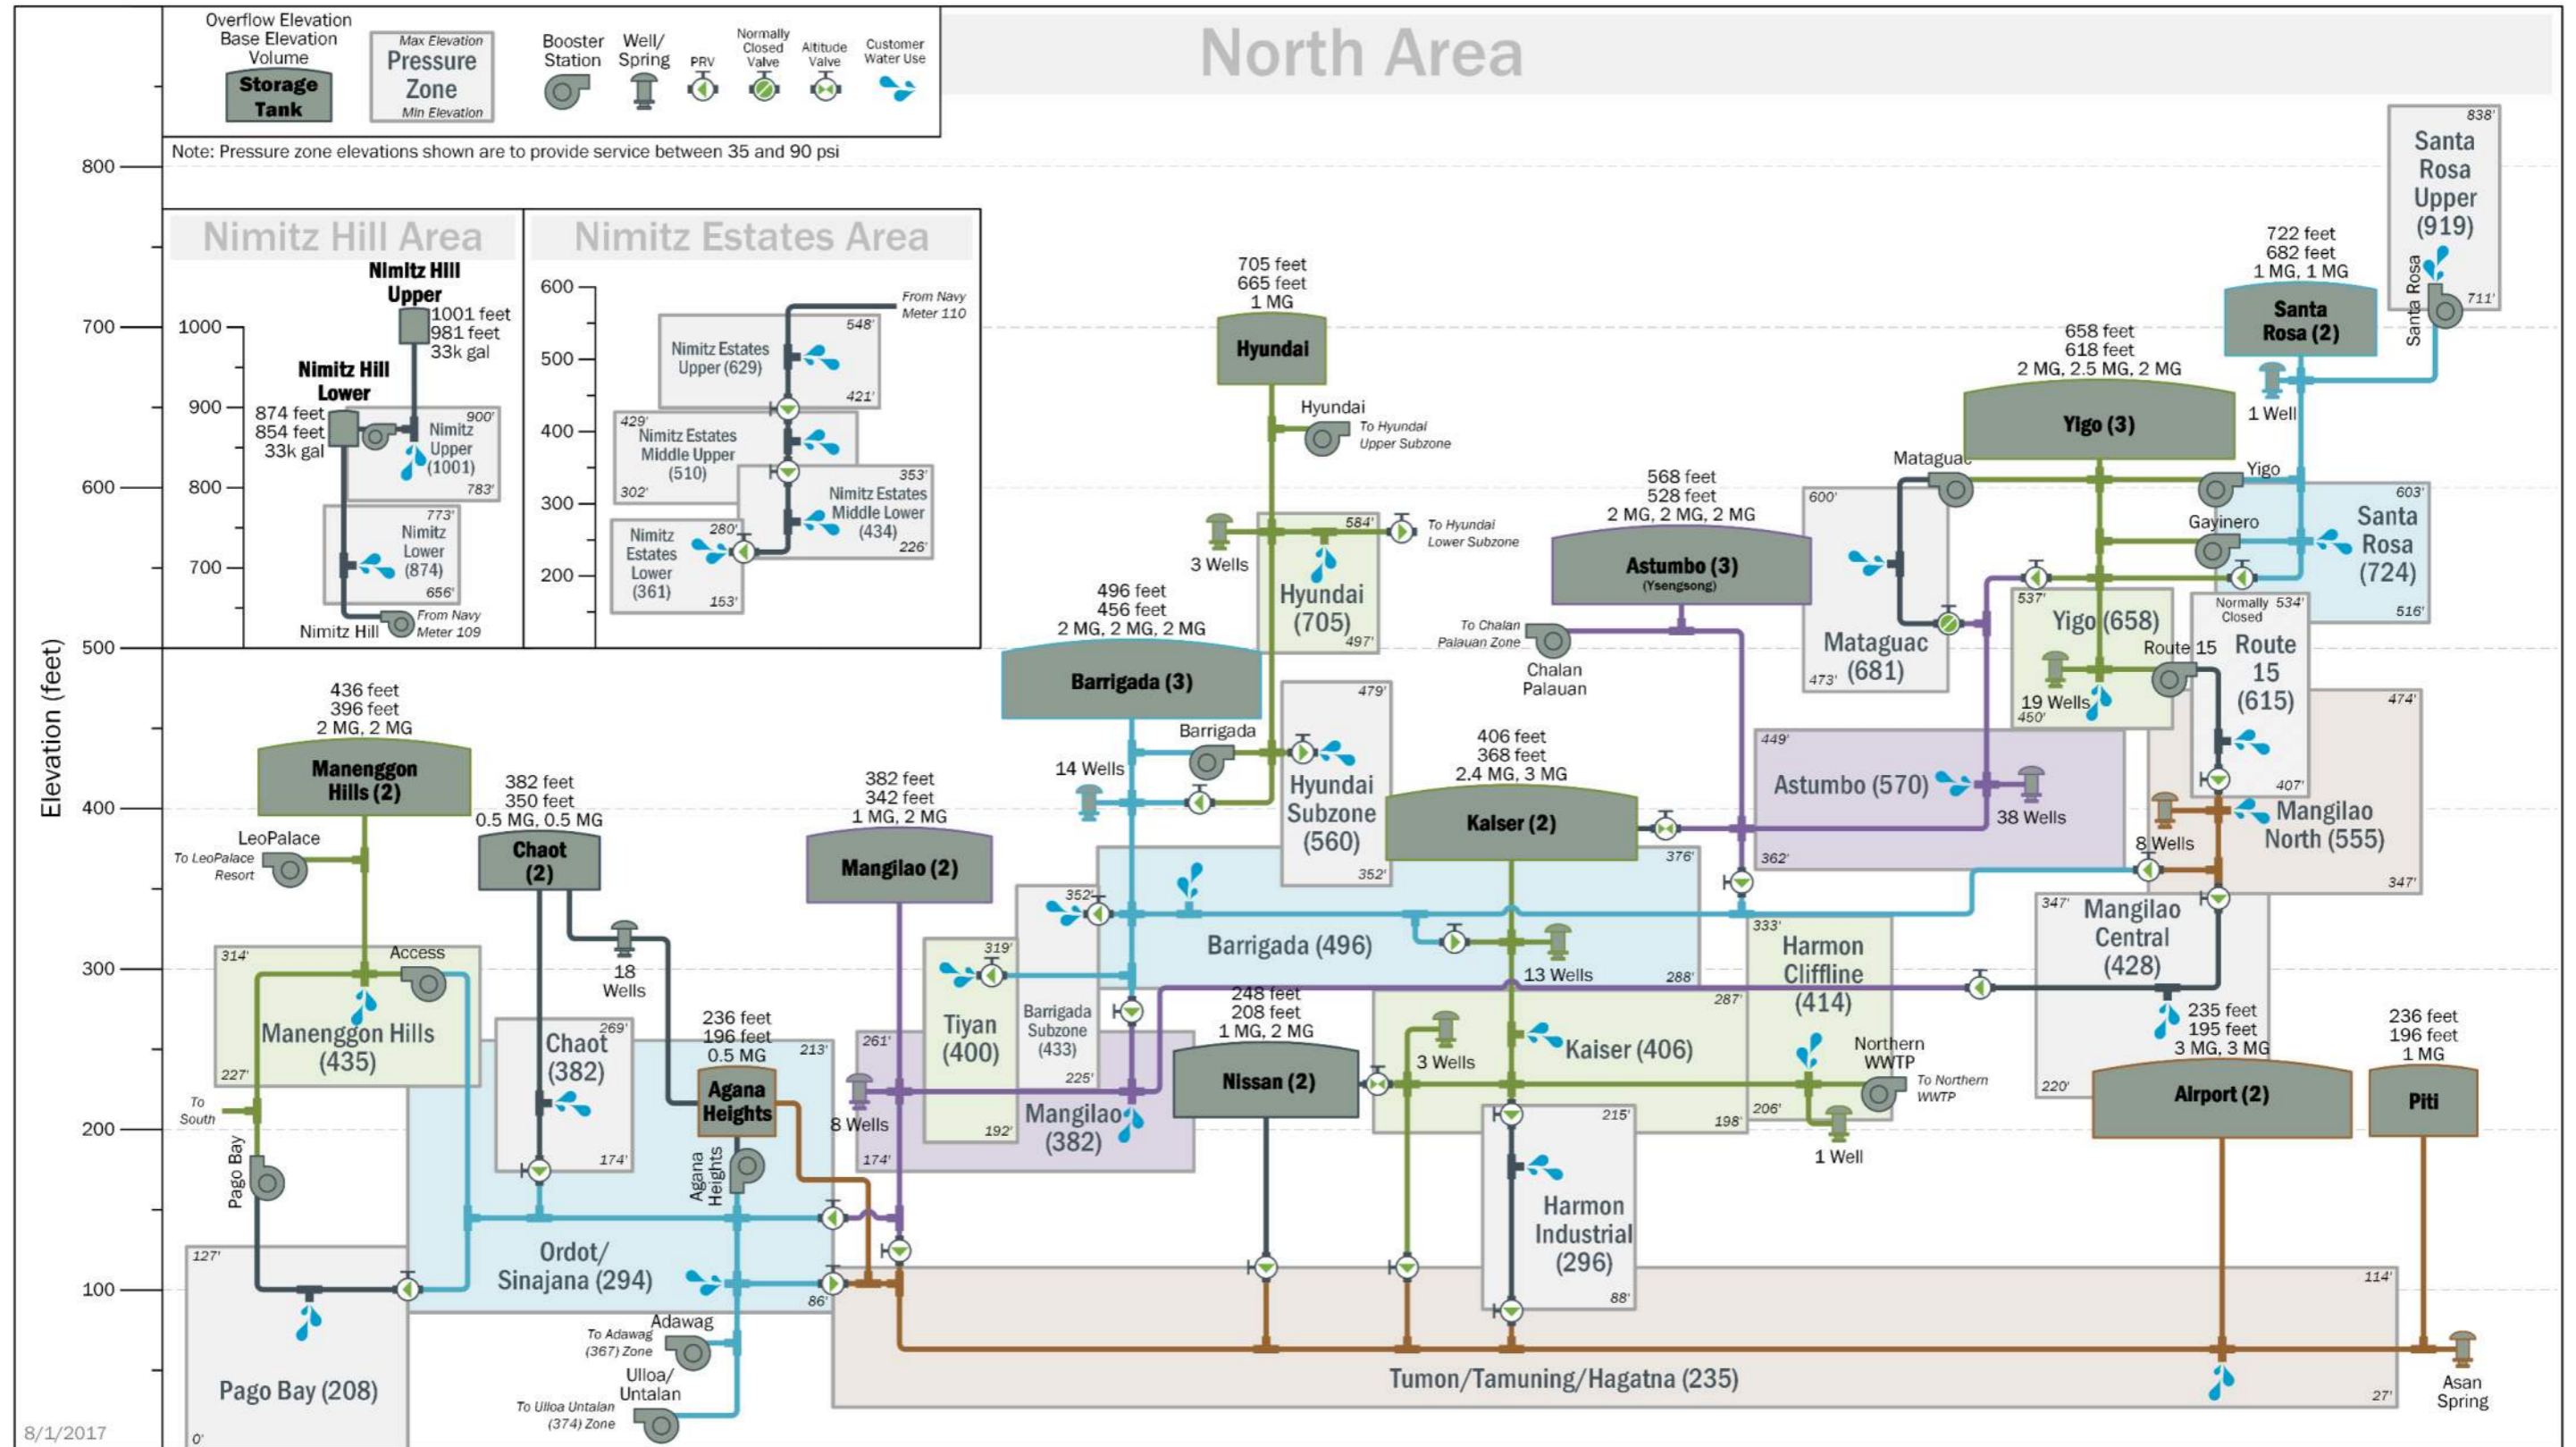
Figure 8-14. Proposed Water Distribution System Hydraulic Schematic (North)
