Prepared for
Guam Waterworks Authority

Water Resources Master Plan Update

Volume 2: Water System

Final | August 2018

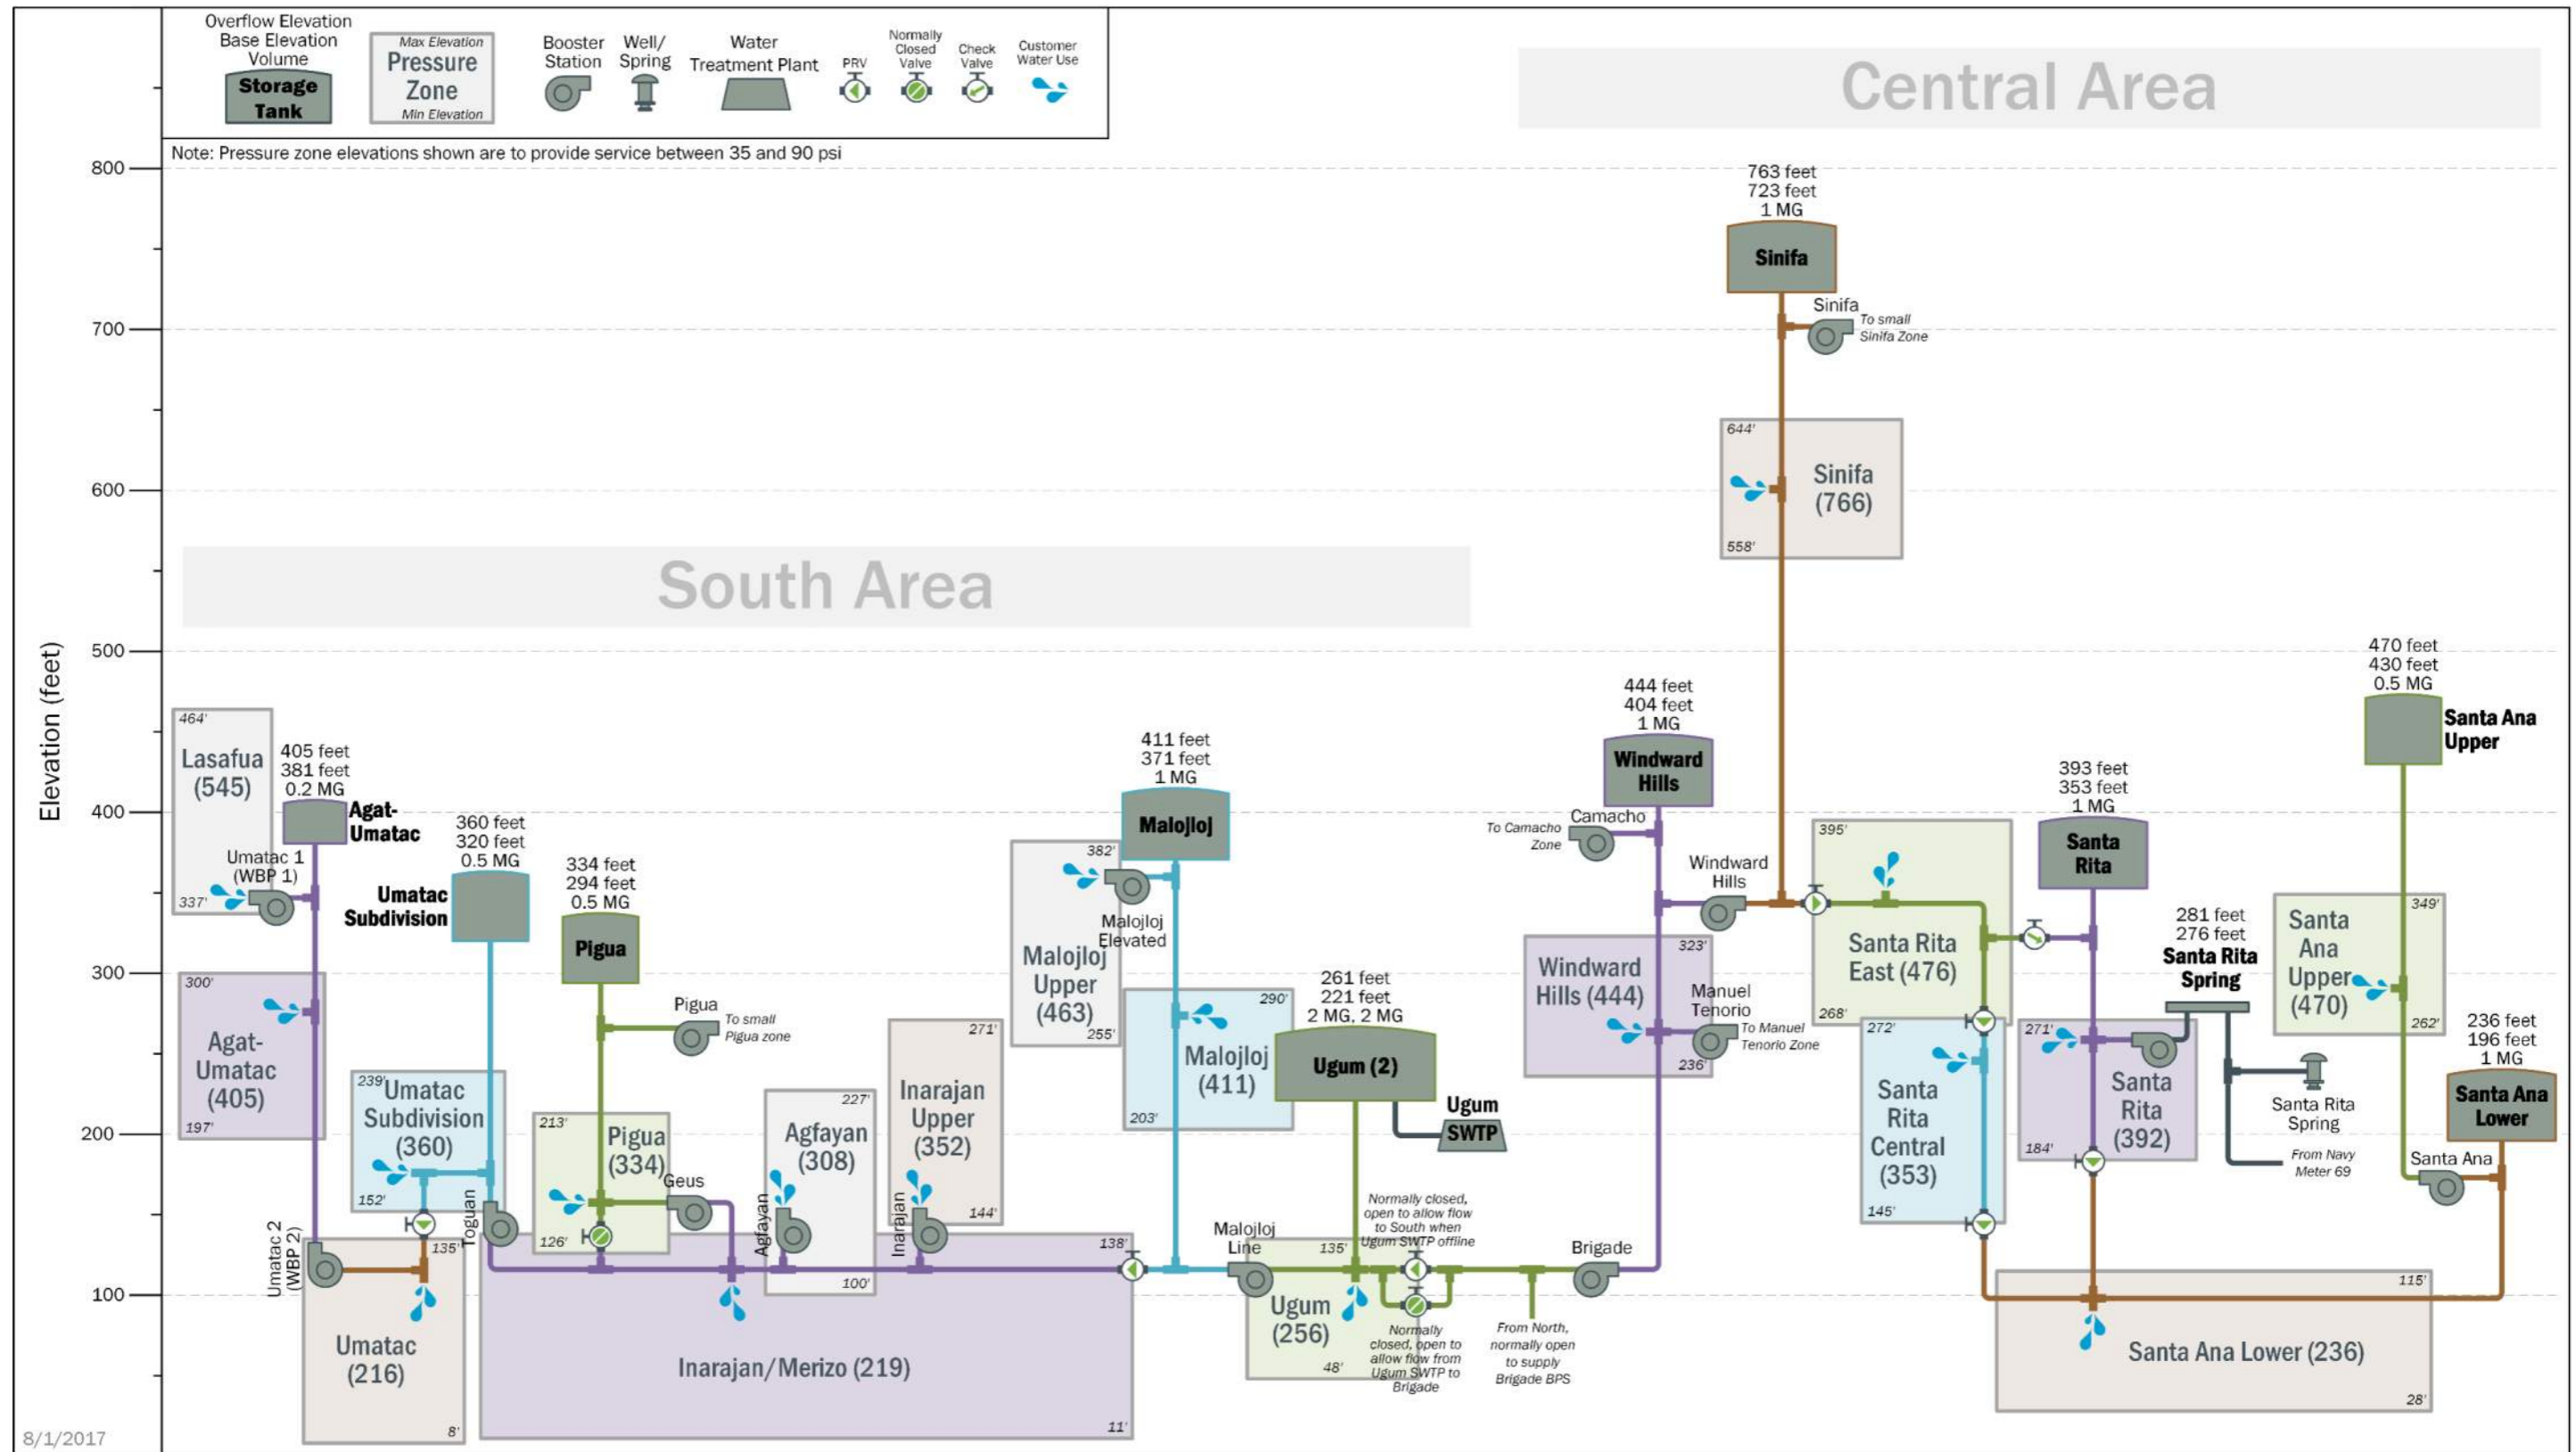
Figure 8-15. Proposed Water Distribution System Hydraulic Schematic (South and Central)

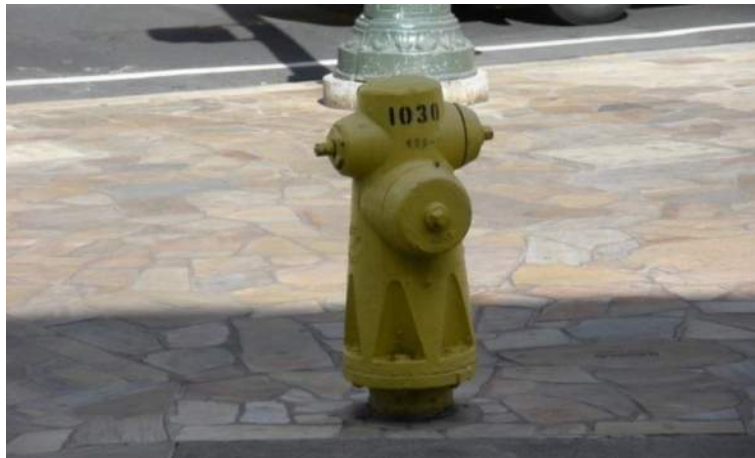
Figure 10-1. Fire Hydrant with Painted ID

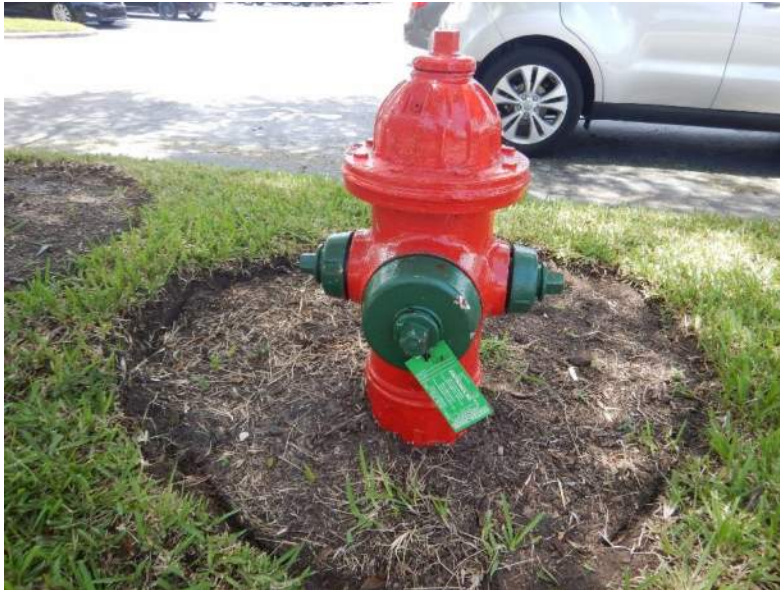
Figure 10-2. Fire Hydrant Color Coded by Fire Flow
