Subject: Percolation Test, Inarajan Sewer Treatment Plant

Inarajan Percolation test MCB Rev 2006FEB06

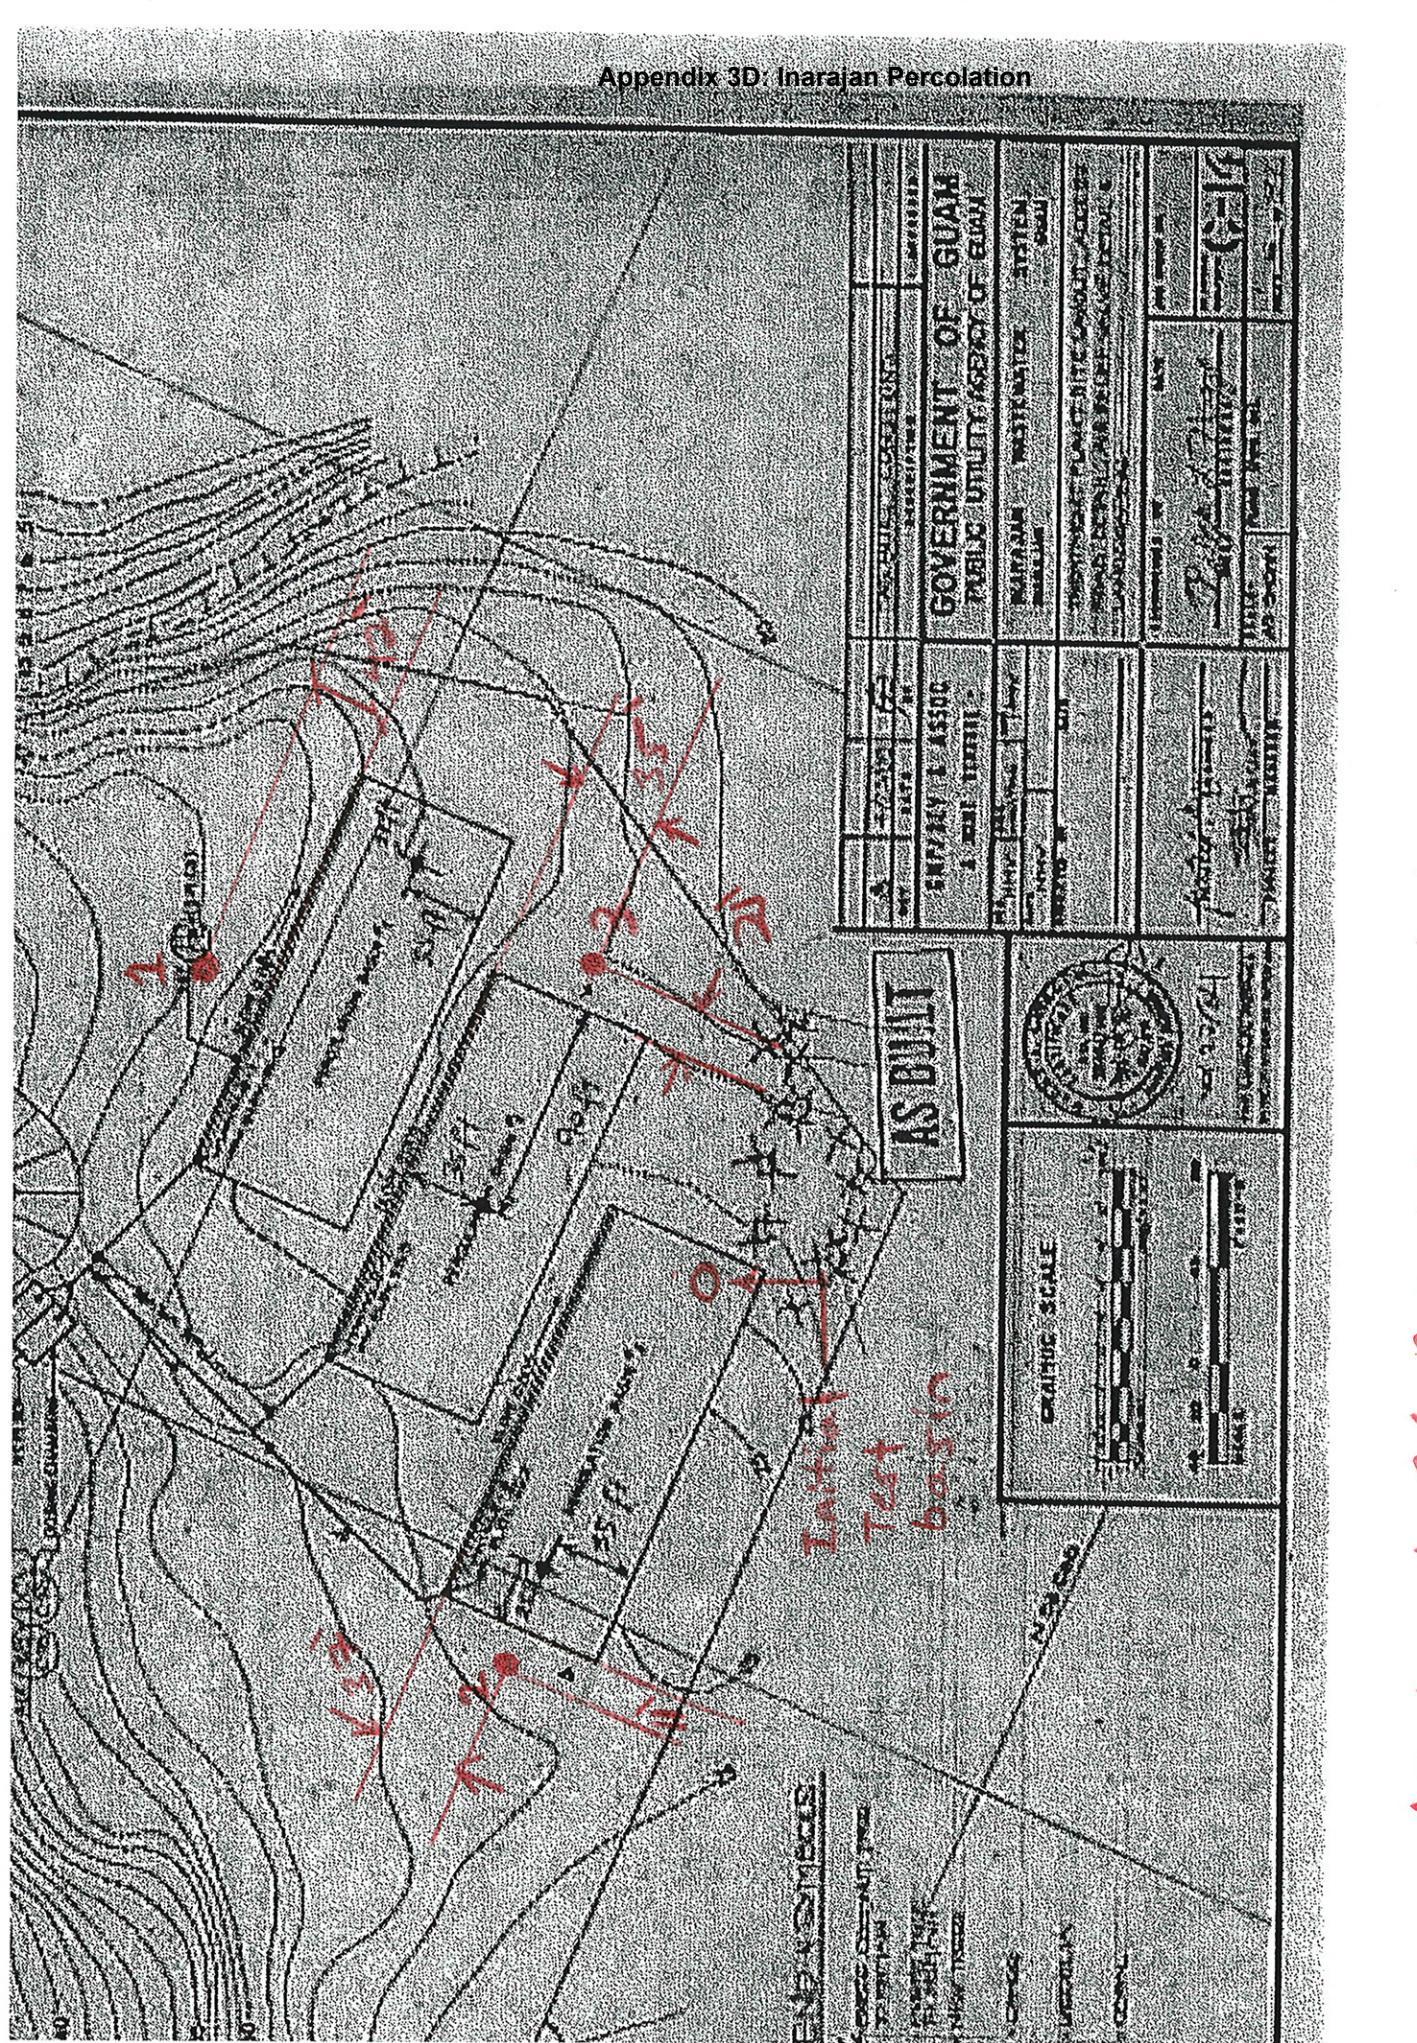
Attachment 2: Percolation pit Lucations

The two northern percolation basins (basins 1 and 2) were in operation during the percolation tests. A percolation test was attempted within the third (southern most) percolation basin. A consistent steady head above the ground surface was not attainable due to the rapid infiltration (100 gallon within 10 minutes) of the percolation basin. The percolation basins all contained drain rock (~2-inch diameter) bottoms. Due to the rapid infiltration through the imported material within the basins, the three percolation tests were conducted outside and adjacent to the three basins in what appeared to be native material. See Attachment 2.
